Launch and Entry Failures

- STS 51-L - Challenger
- STS 107 - Columbia
- AMROC SET-1

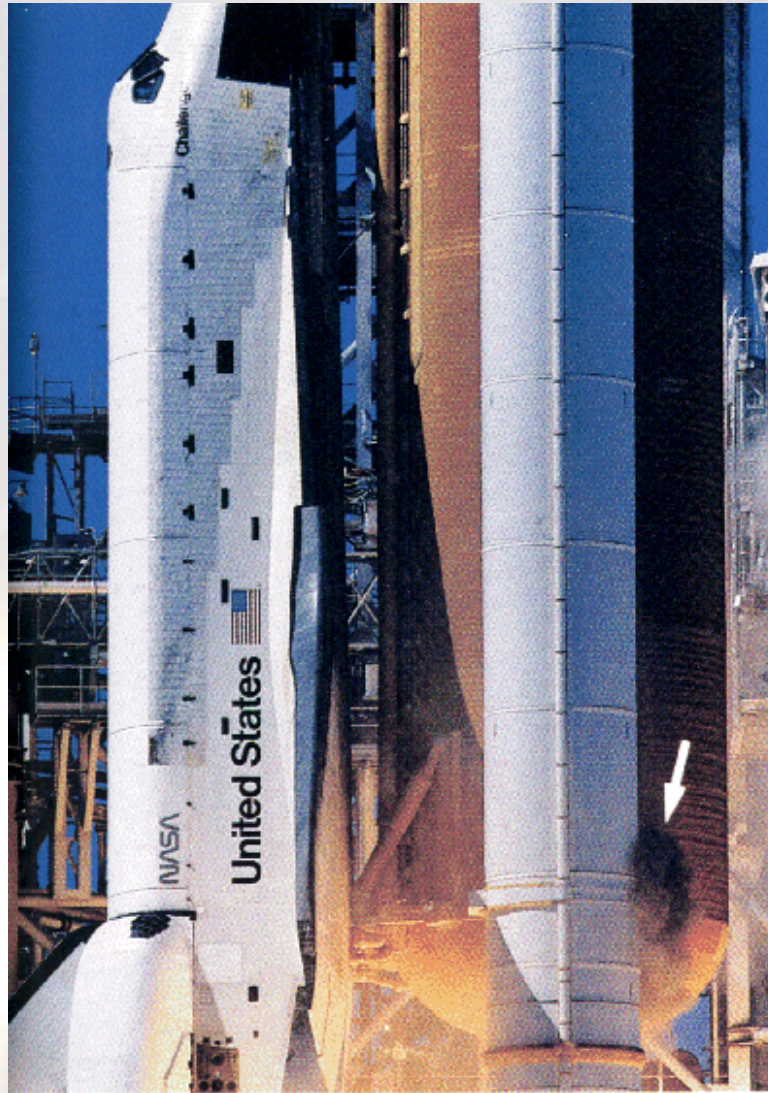
Black Smoke Plumes from Aft Field Joint

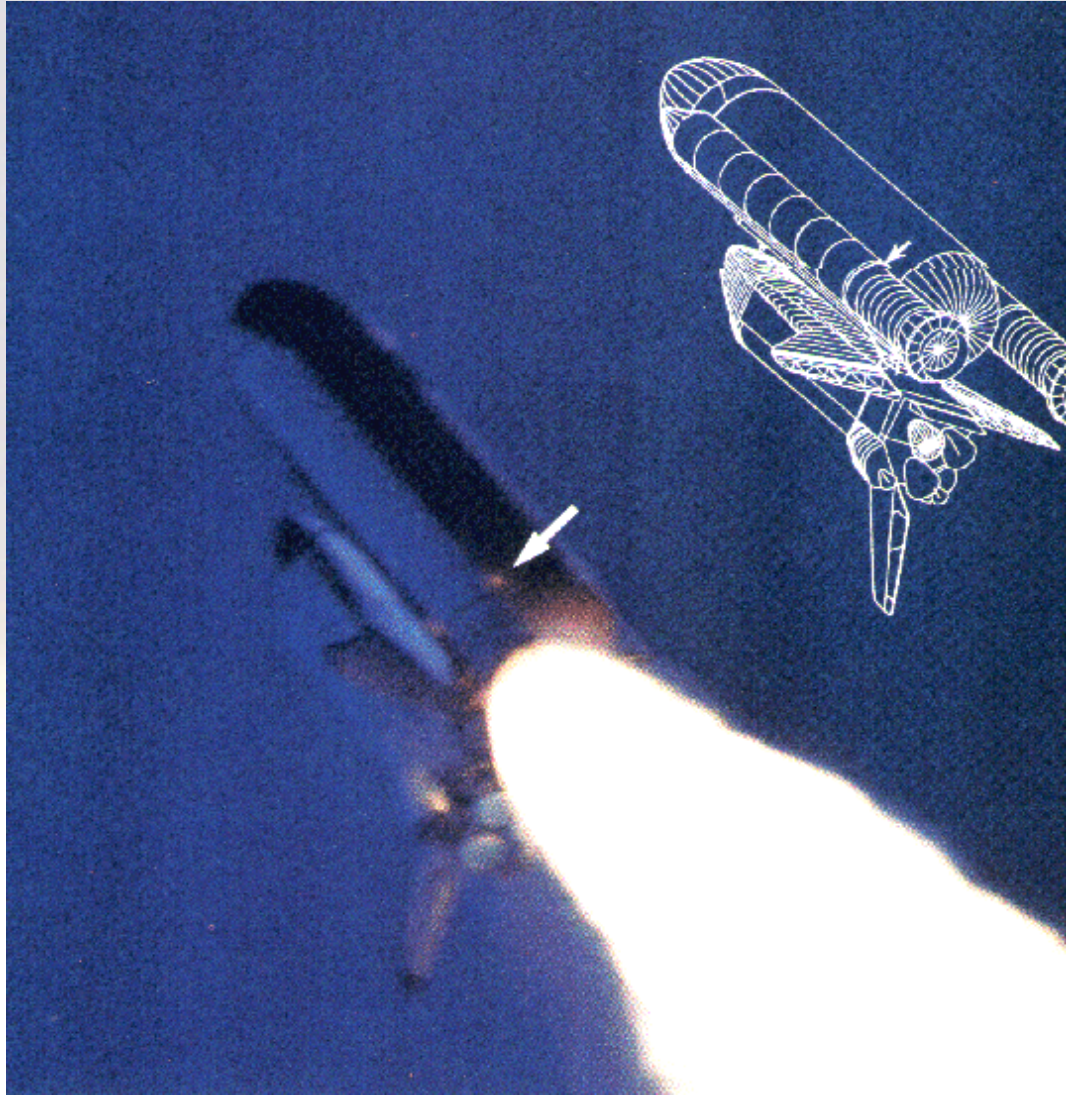
T+58 sec - Appearance of External Flame

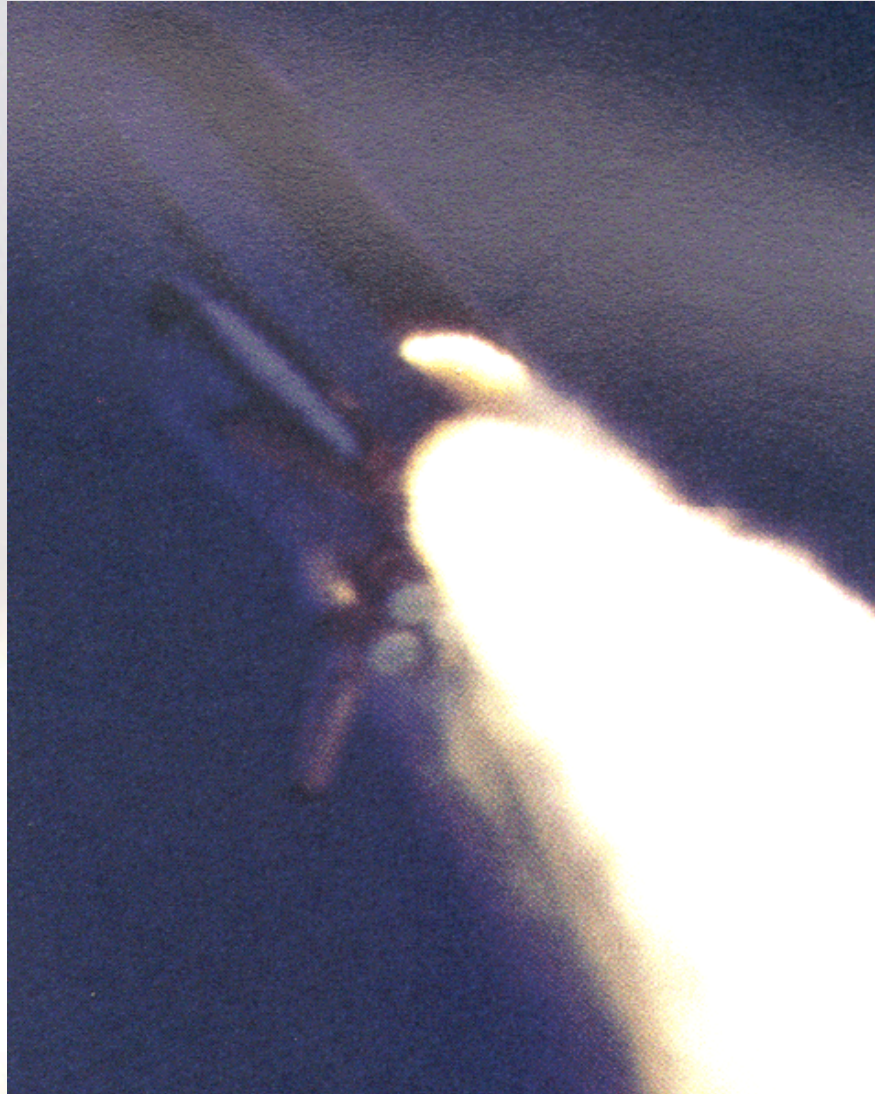
Flame Hitting Aft Attach Fixture and ET

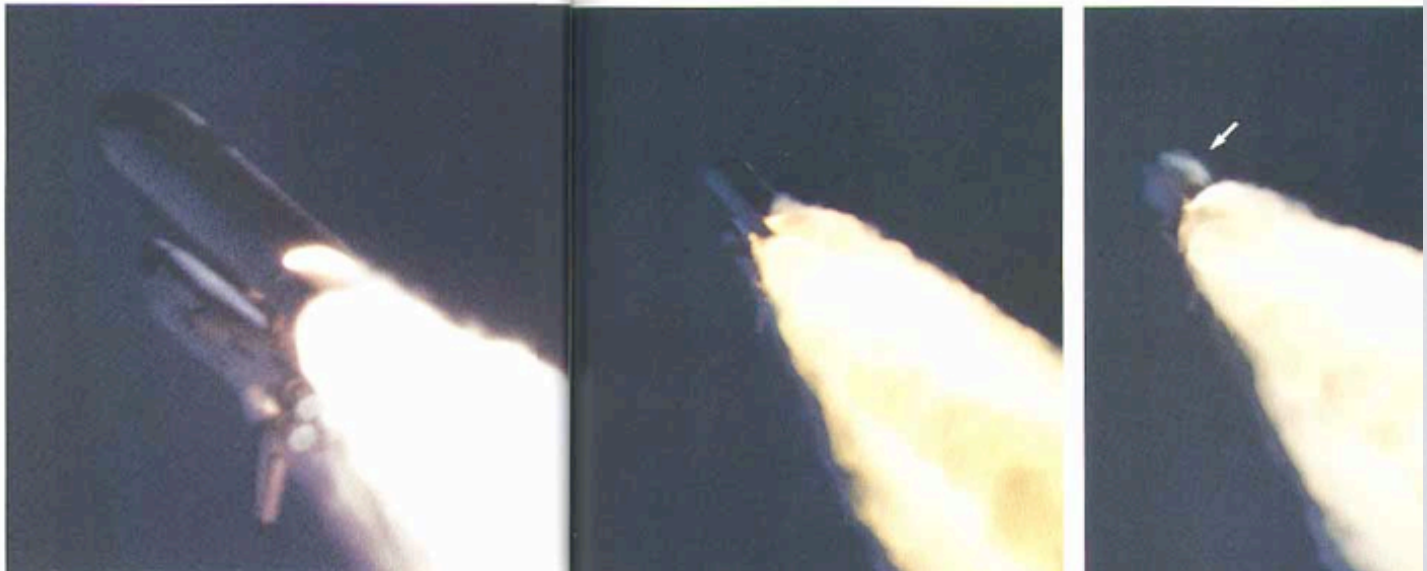
At 58.786 seconds, the first flicker of flame appeared. Barely visible above, it grew into a large plume and began to impinge on the External Tank at about 60 seconds. Flame is highlighted in the computer drawing between the right booster and the tank, as in the case of earlier smoke puffs. At far right (arrow), vapor is seen escaping from the supposedly breached External Tank.

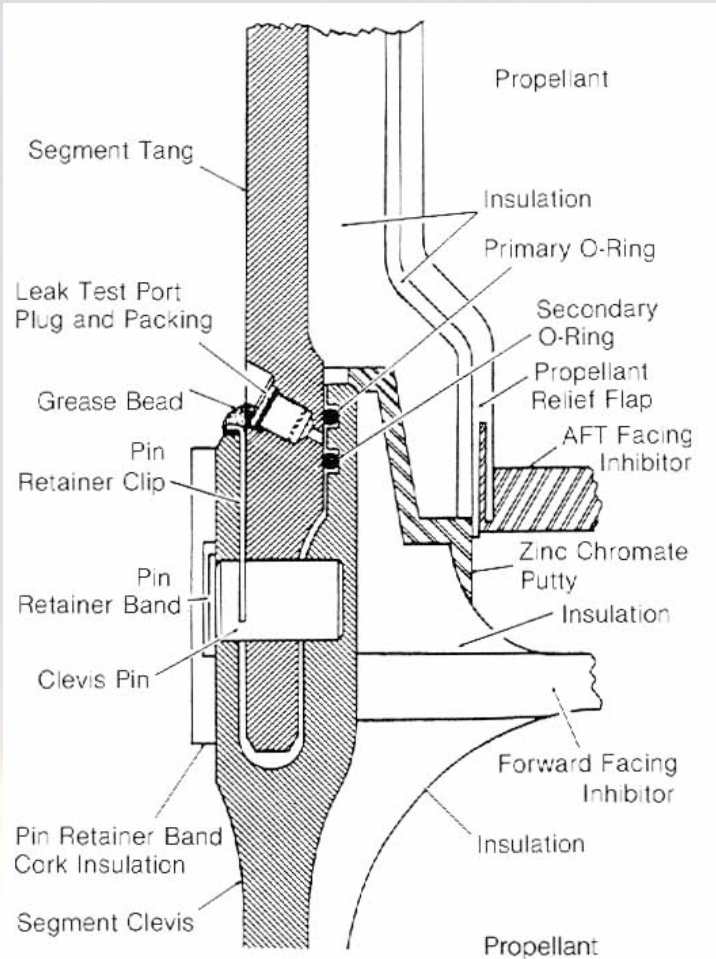
Original SRB Field Joint Design

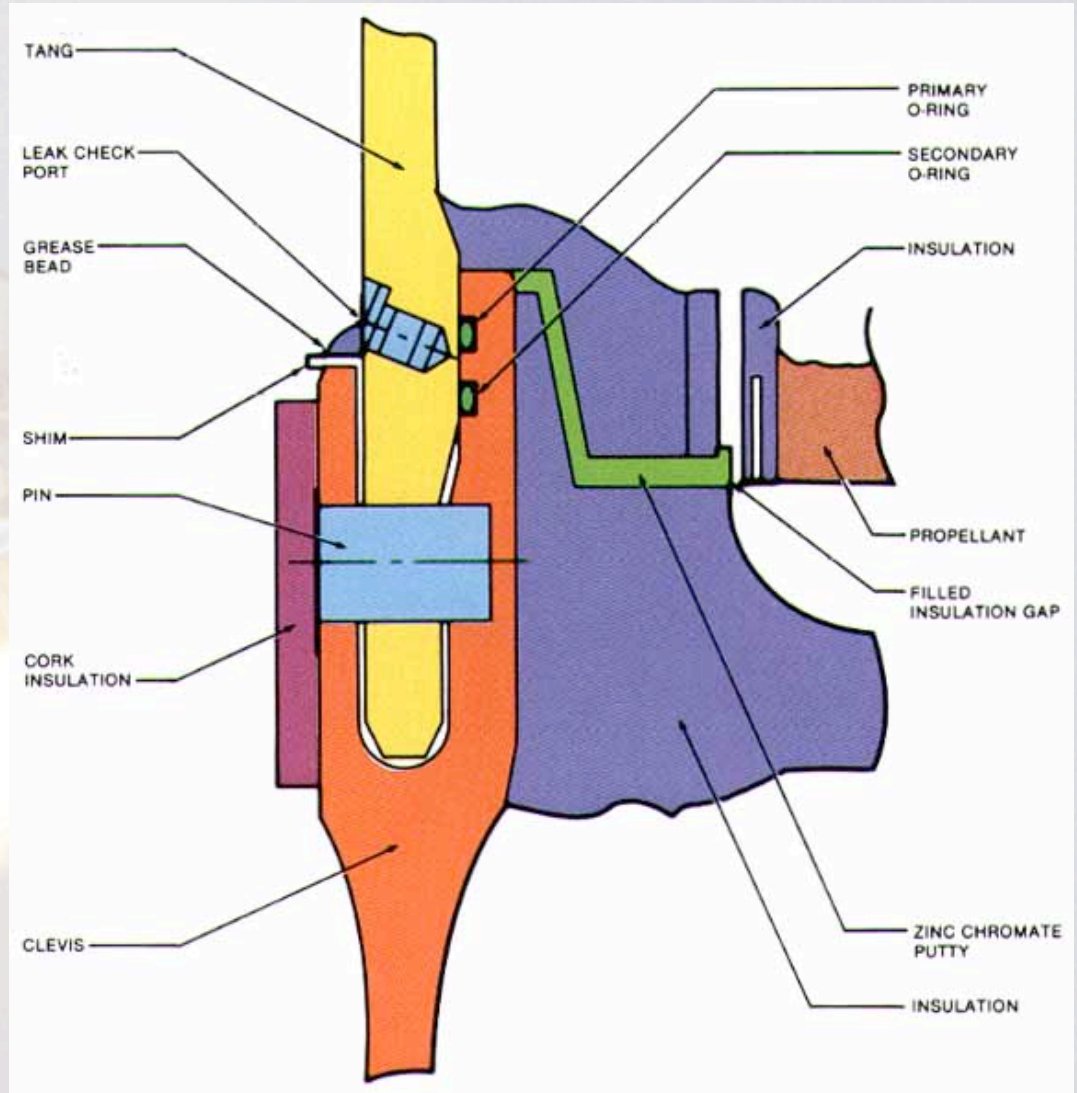
Figure 14
 Solid Rocket Motor cross section shows positions of tang, clevis and O-rings. Putty lines the joint on the side toward the propellant.

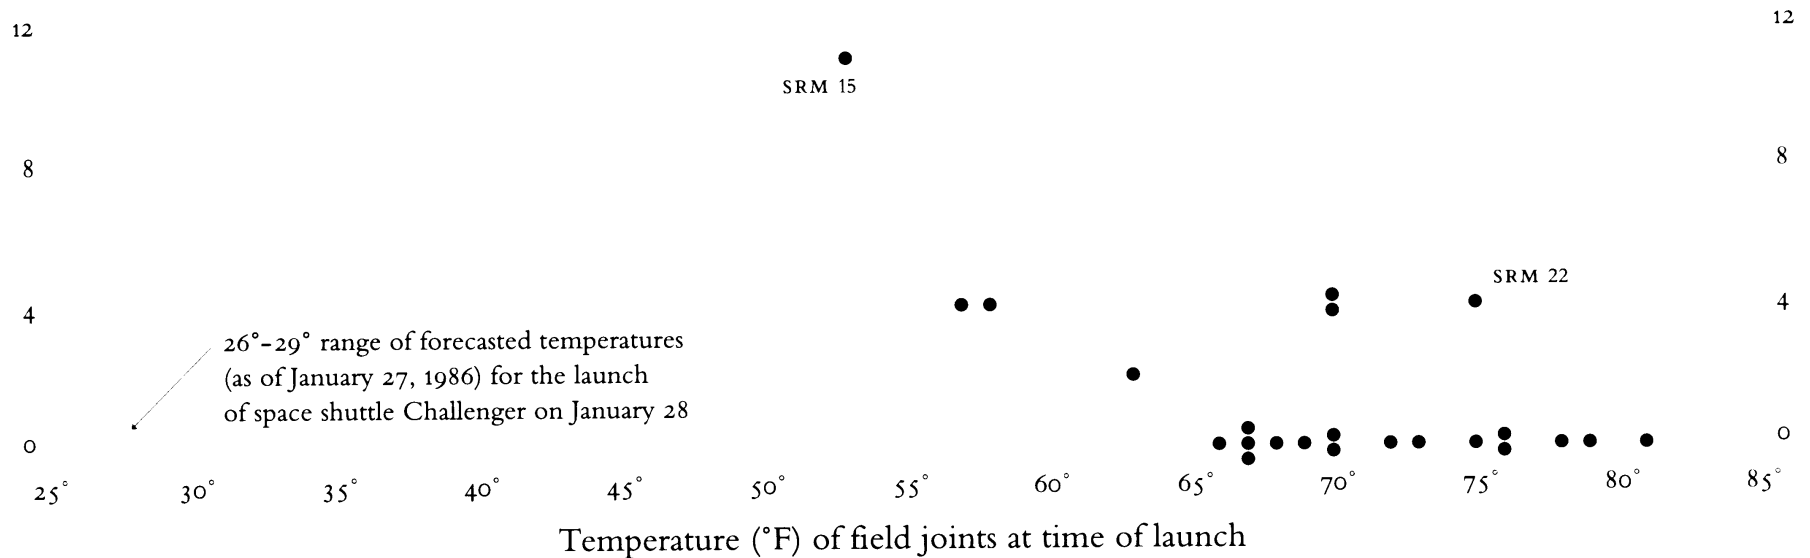
The Slide That Should Have Been...

O-ring damage index, each launch

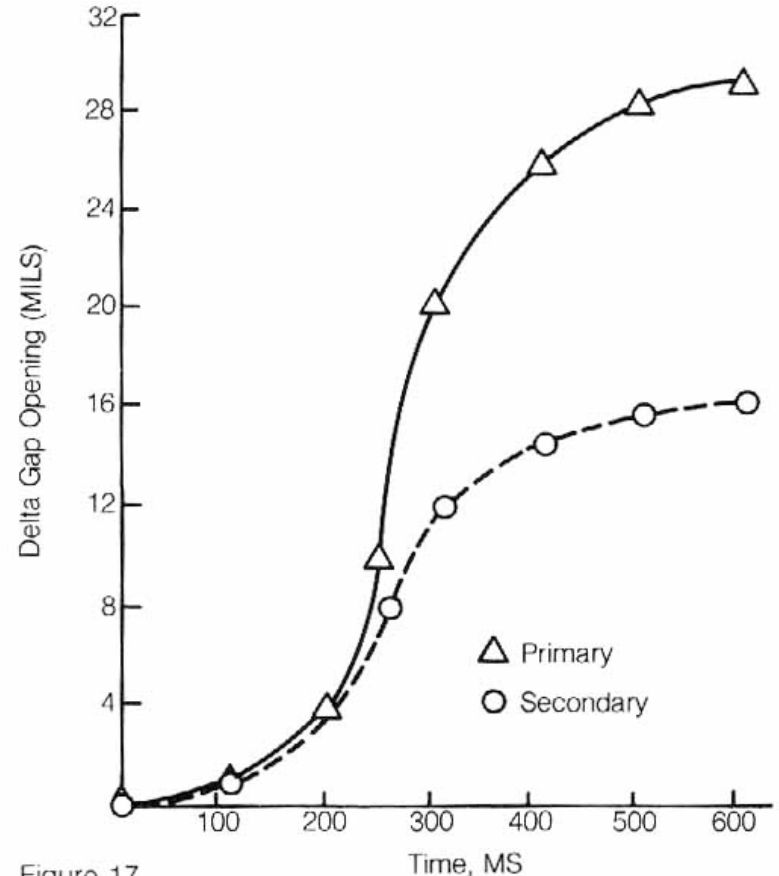
Right Hand SRM Aft Field Joint Primary And Secondary Delta Gap Opening

Figure 17
Graph plots changes in right booster's aft field joint primary and secondary gap openings. Horizontal scale is time in milliseconds from ignition.

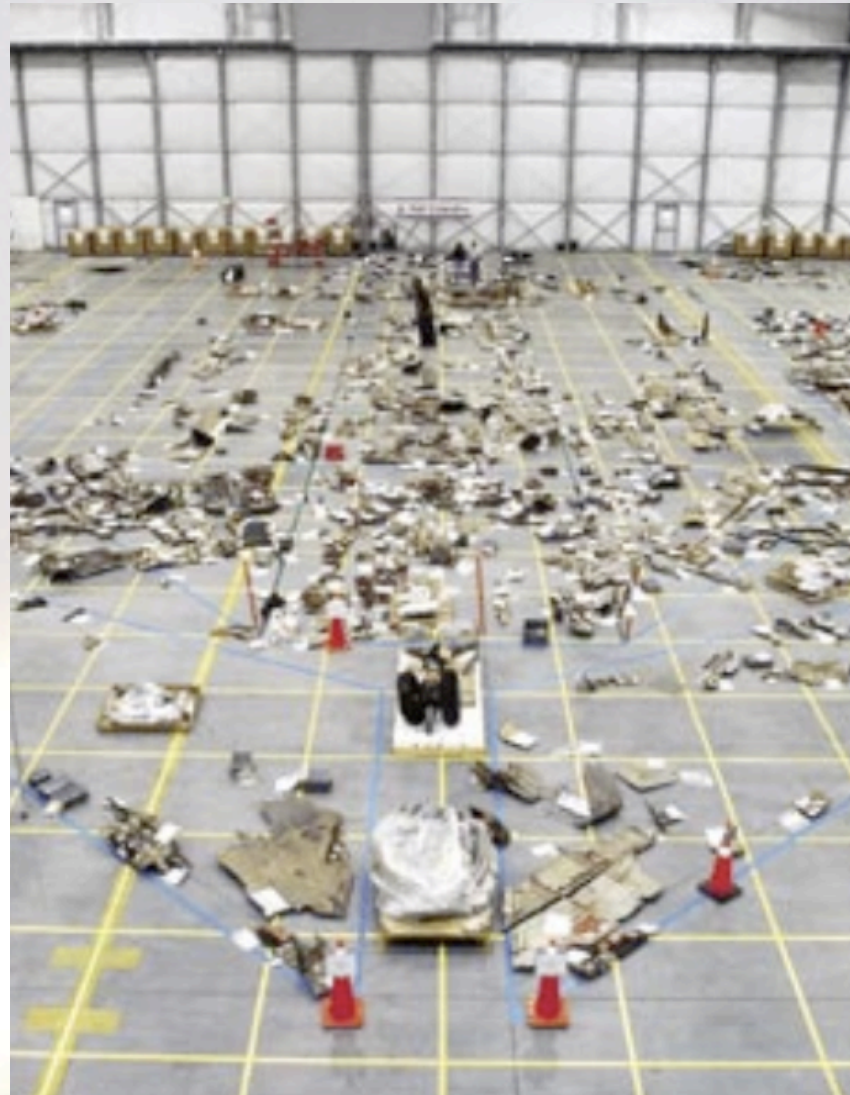
Columbia Debris Reconstruction

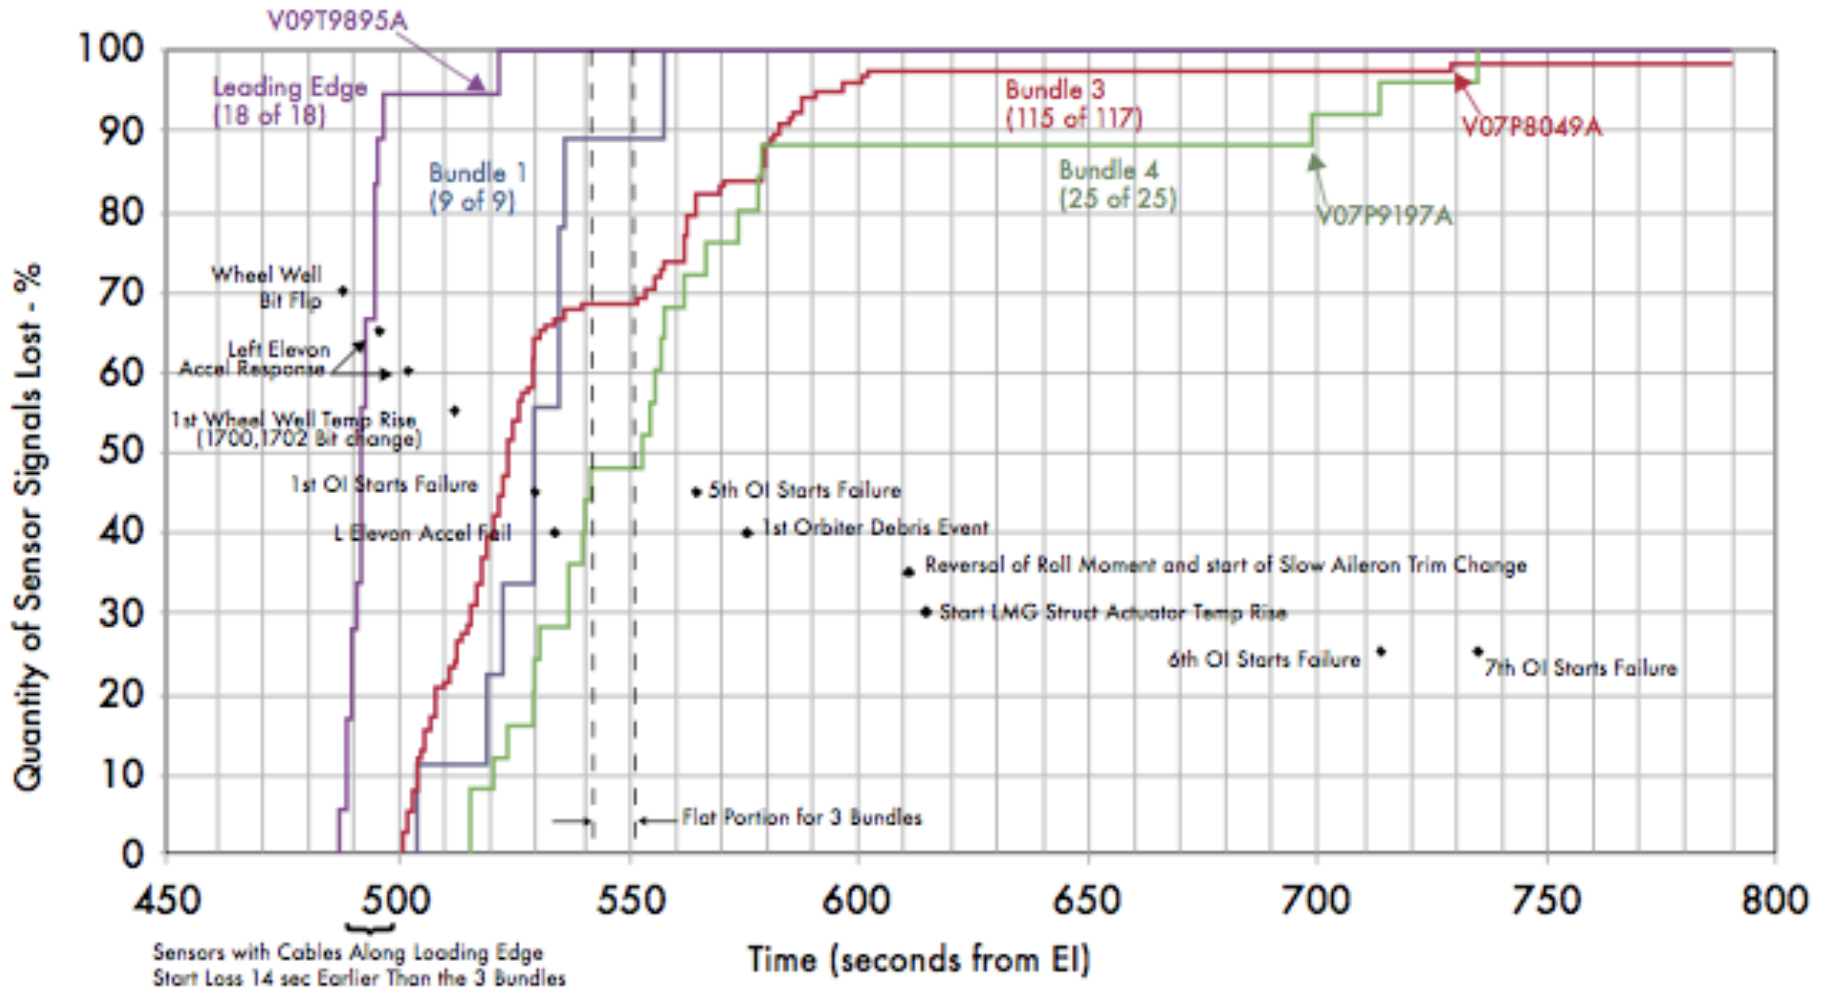
Failure Rates of Sensor Wiring Bundles

Percent Loss of Sensor Signals Versus Time In Left Wing and Wing Leading Edge Wire Bundles

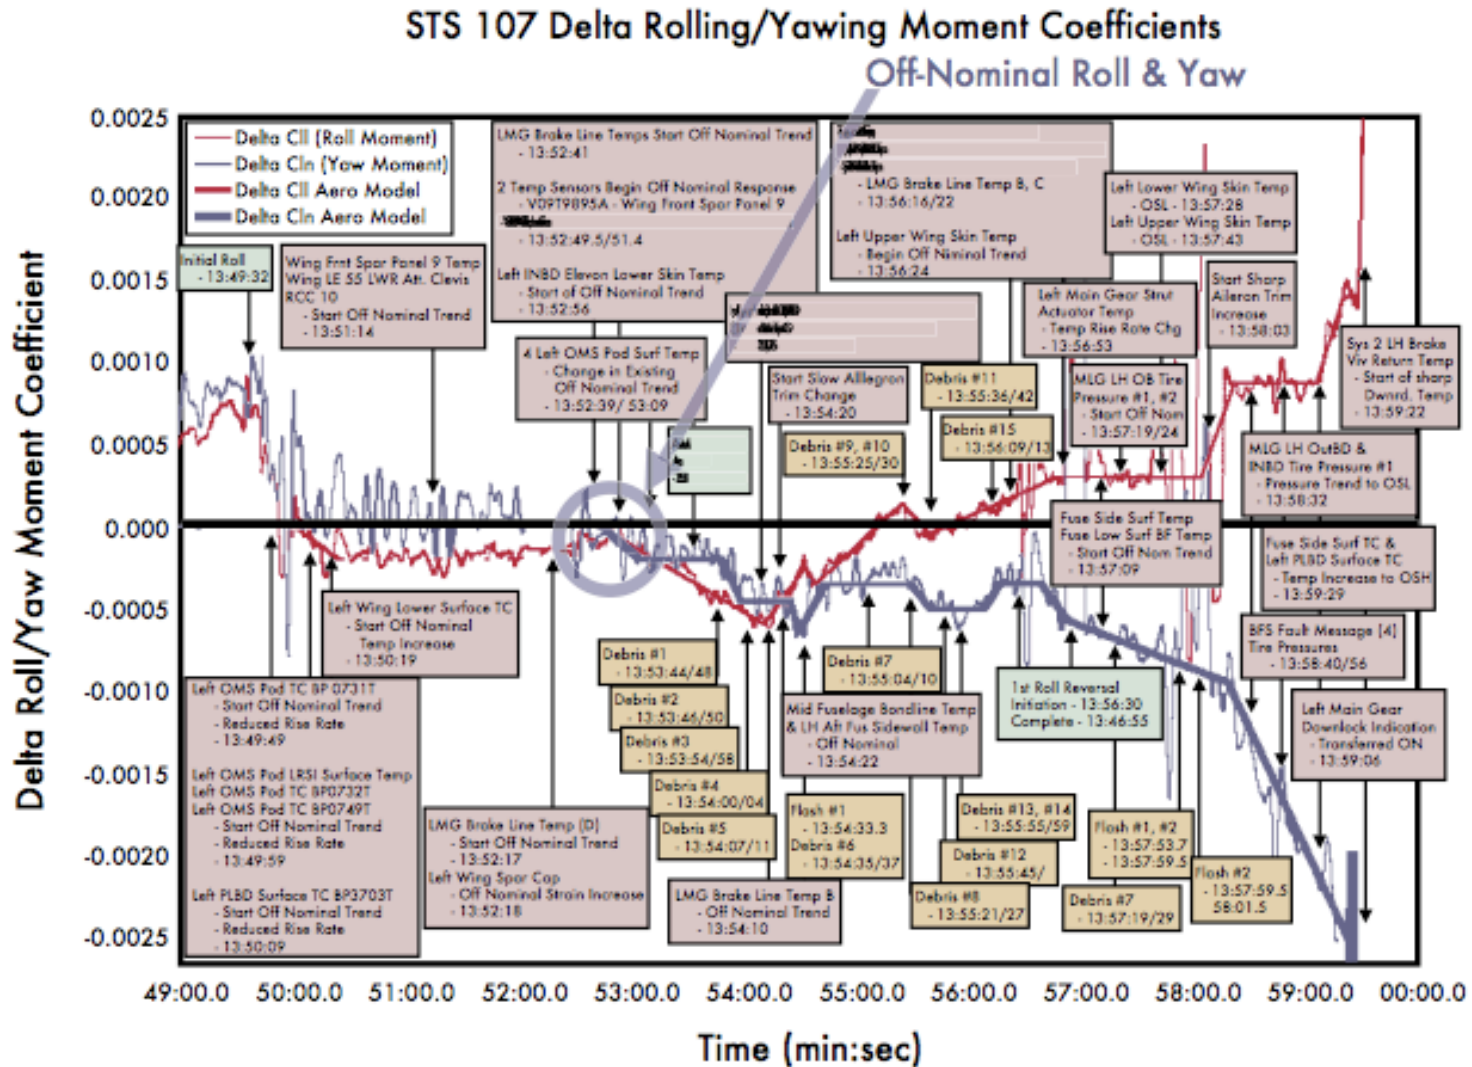
Divergence of Roll/Yaw Angles

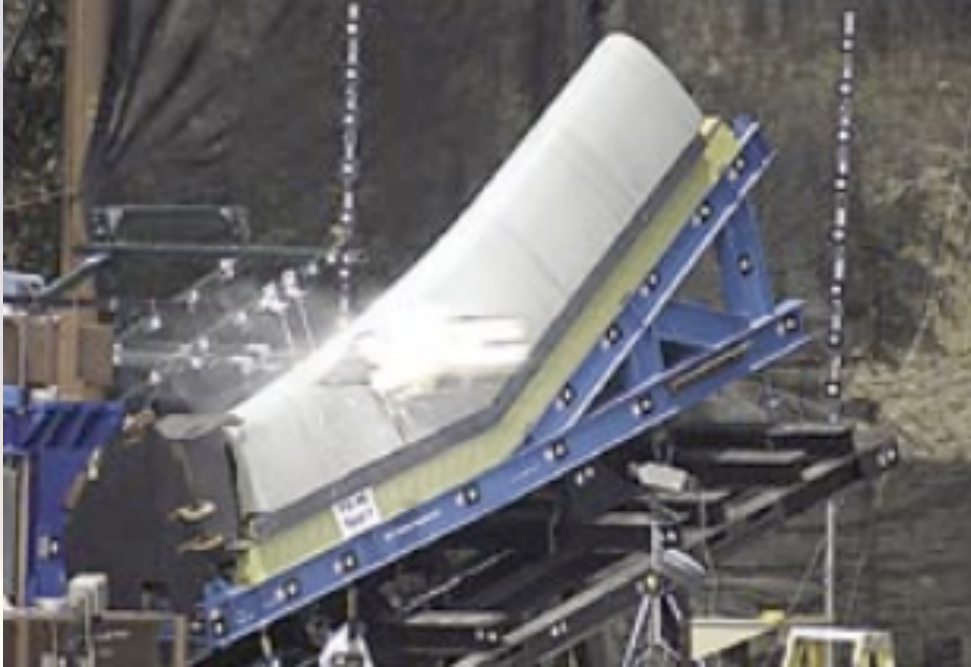
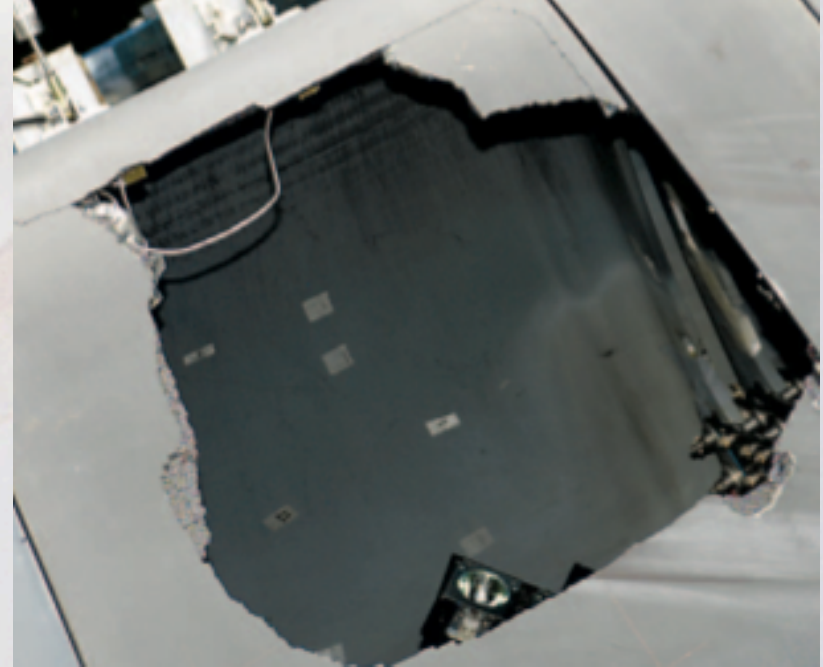
Results of Impact Tests on RCC

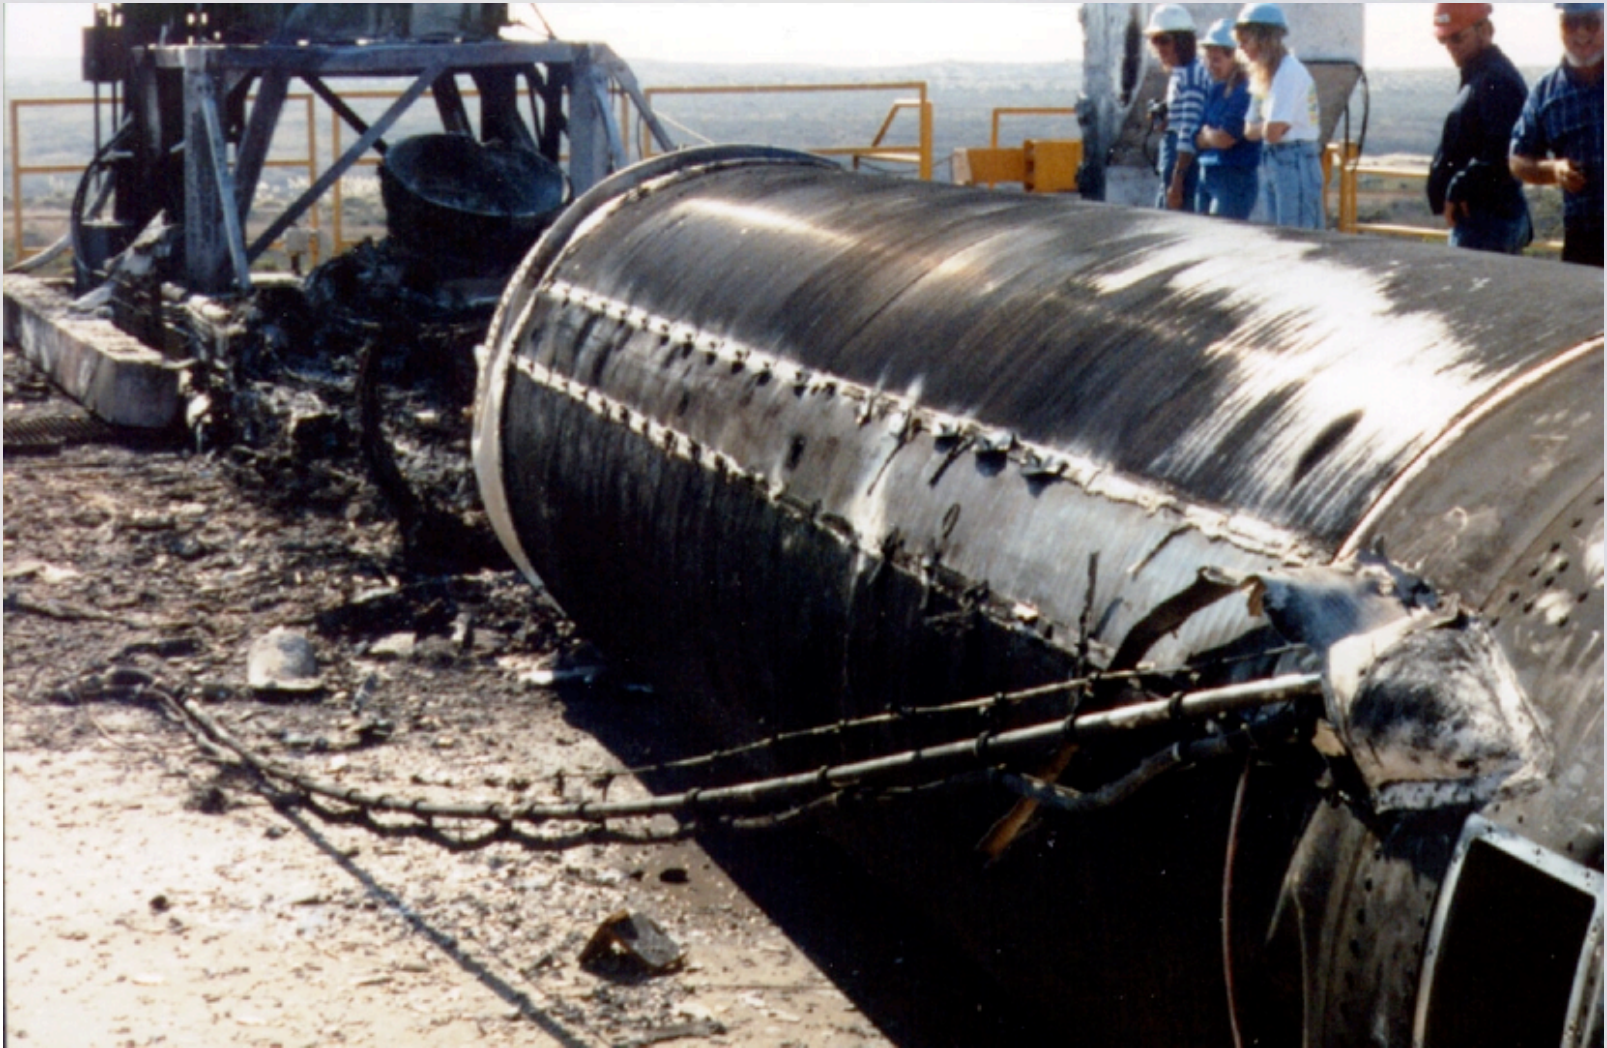
October 6, 1989 - Aftermath
