Launch and Entry Failures

- Atlas ICBM
- STS 51-L - Challenger
- STS 107 - Columbia
- AMROC SET-1

Launch and Entry Failures
ENAE 791 - Launch and Entry Vehicle Design

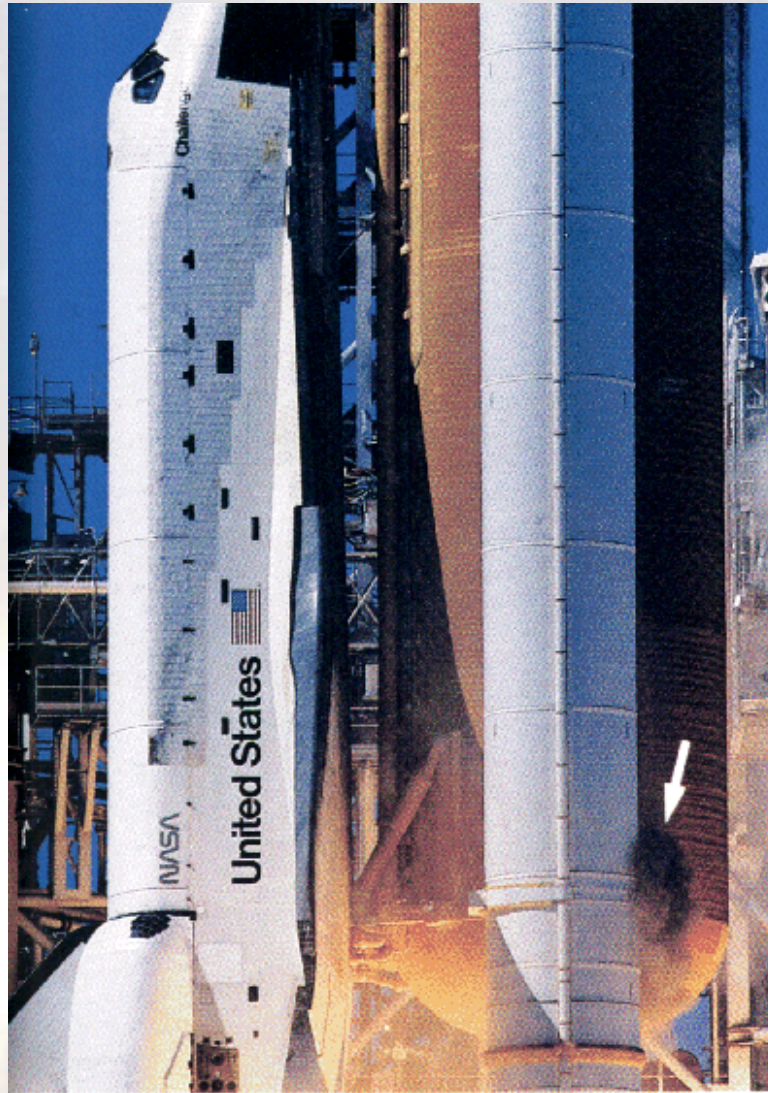
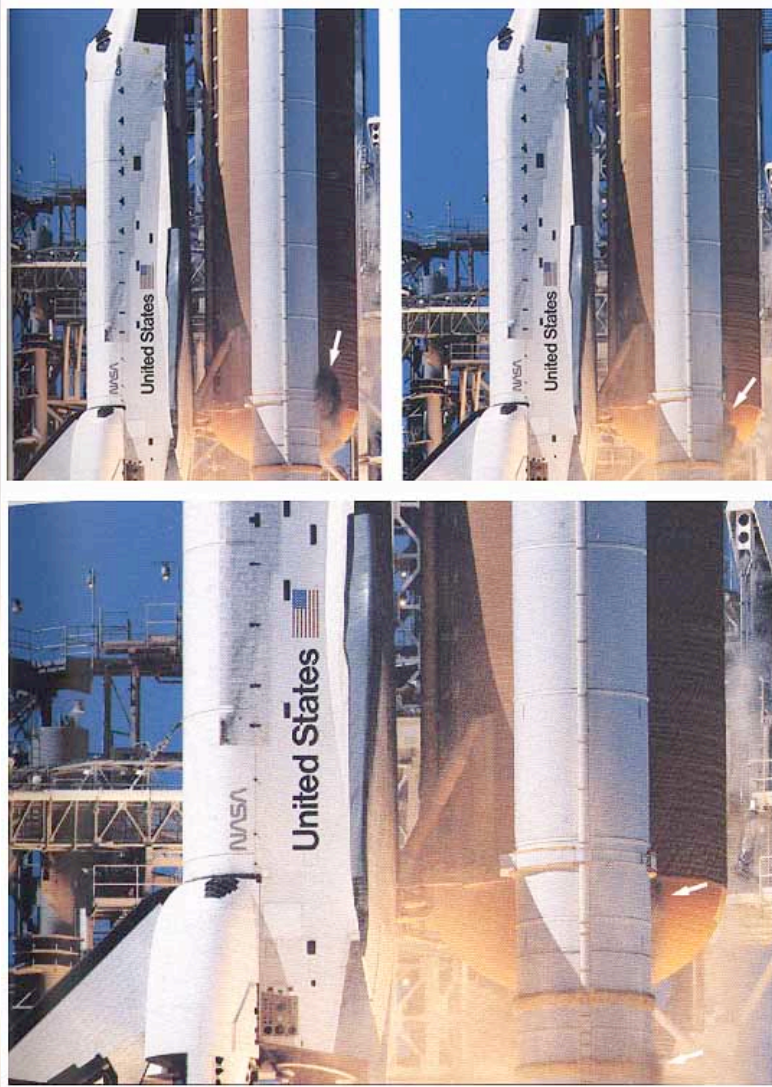
Black Smoke Plumes from Aft Field Joint

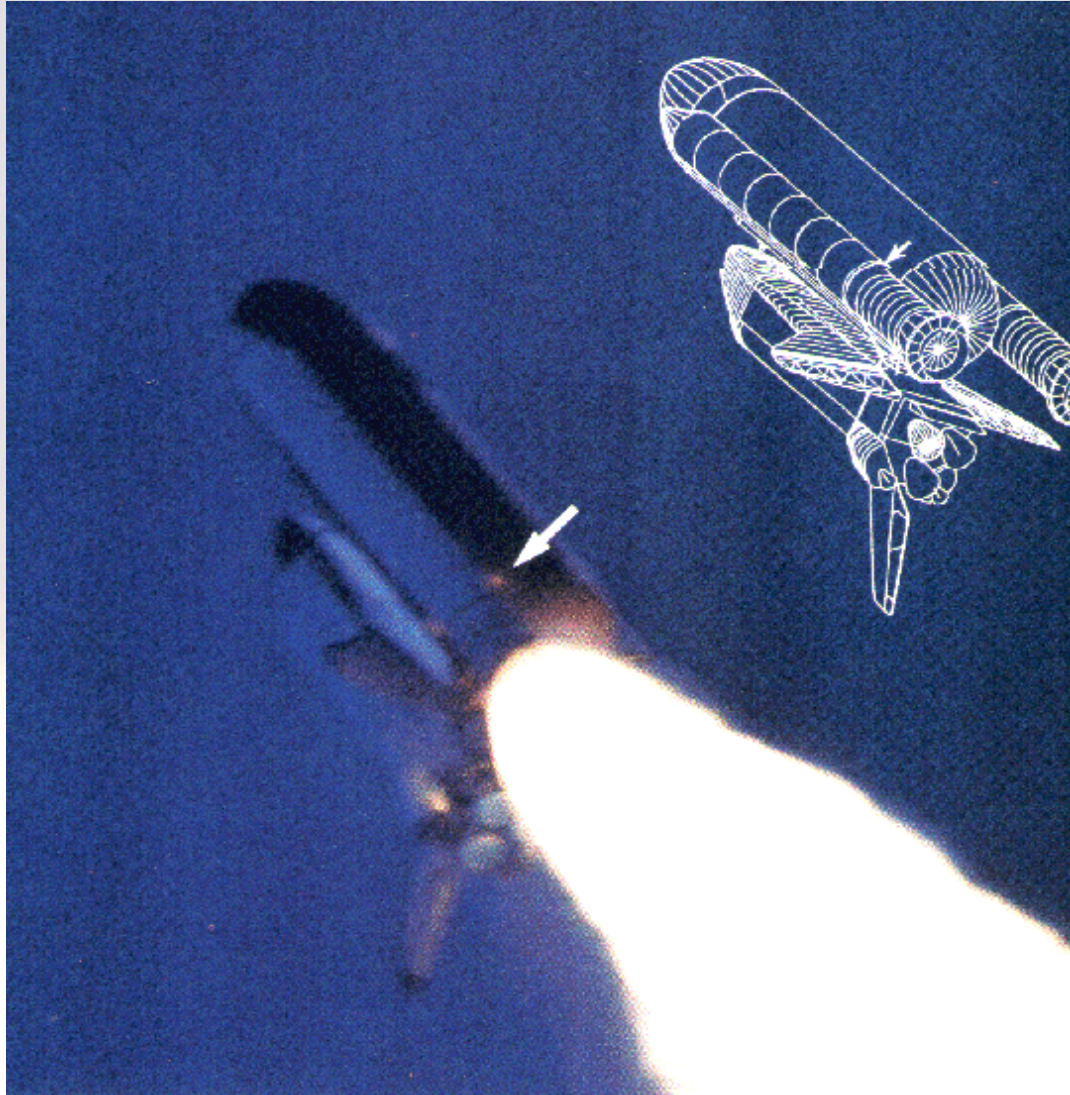
T+58 sec - Appearance of External

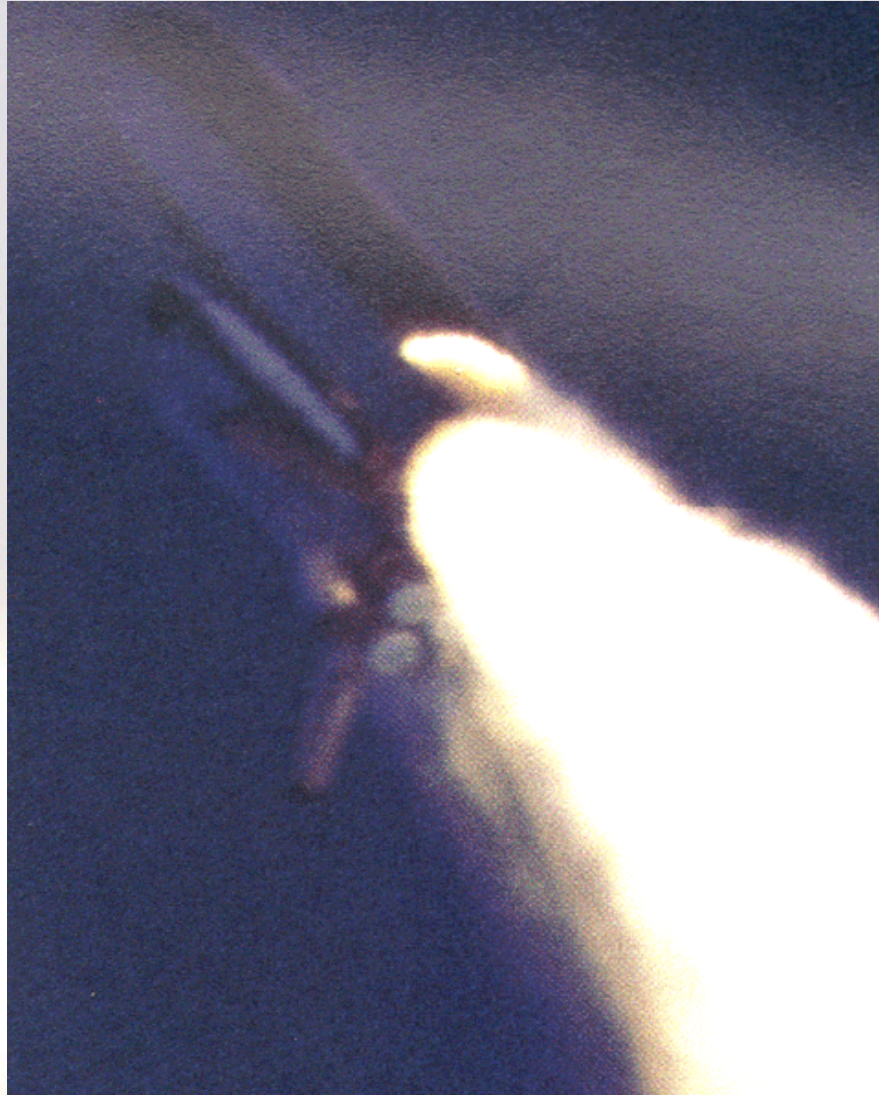
Flame Hitting Aft Attach Fixture and ET

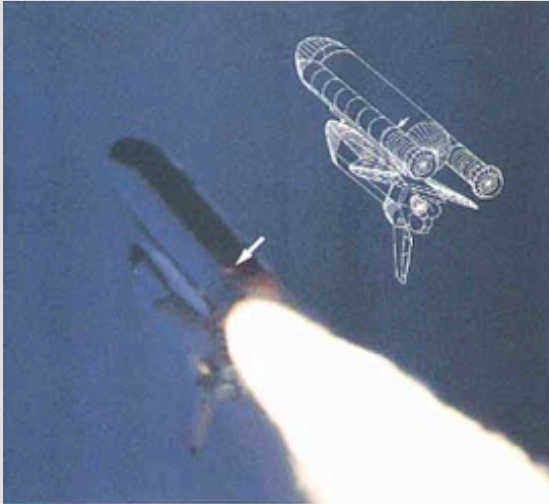
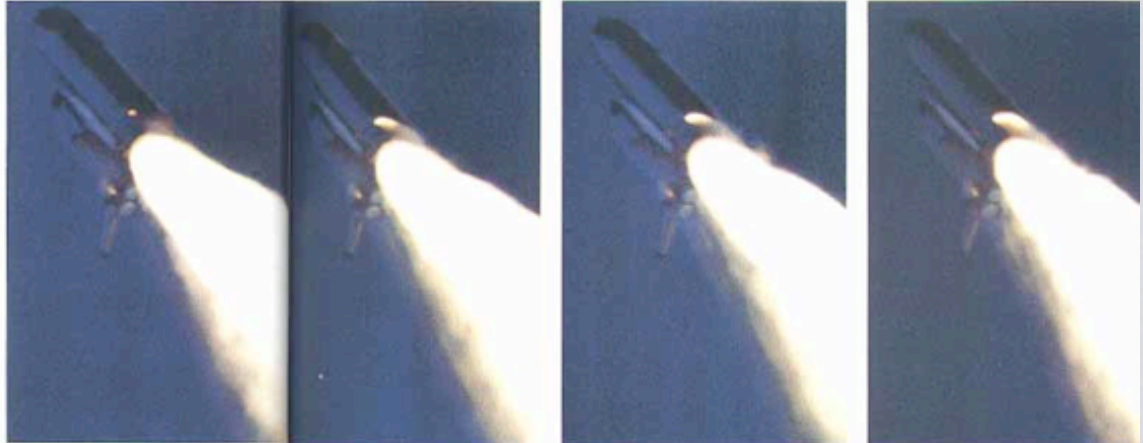
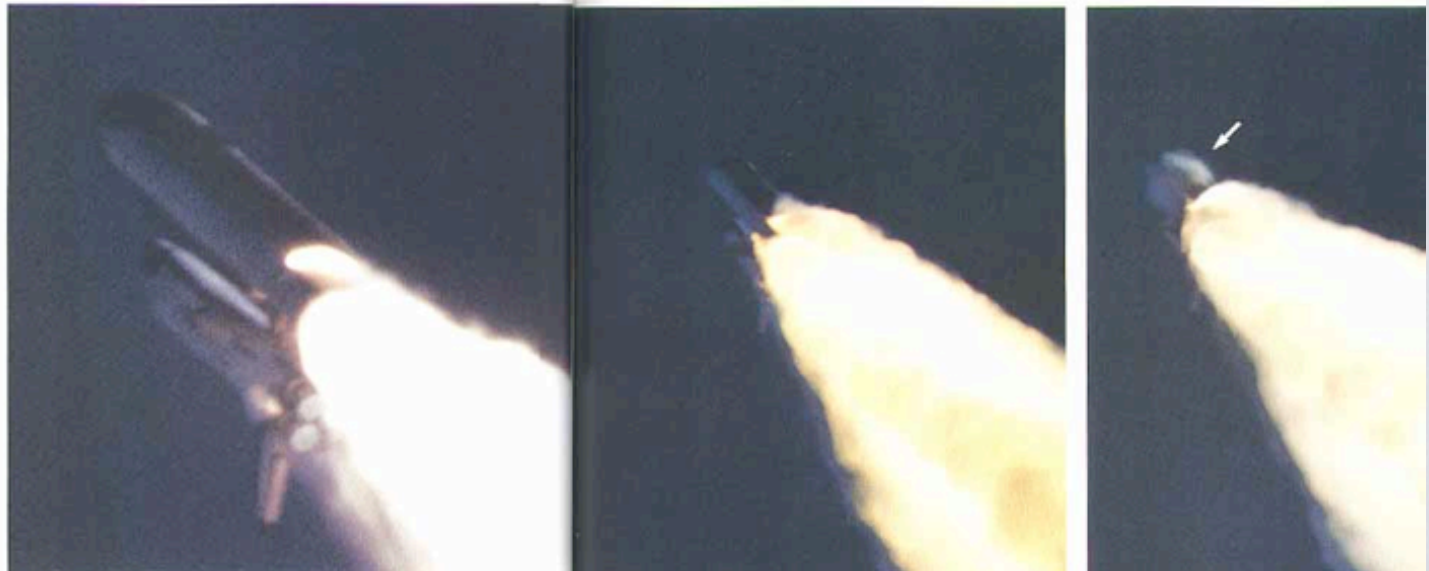
Progression of SRB Burn-through

At 58.786 seconds, the first flicker of flame appeared. Flare visible above. It grew into a large plume and began to impinge on the External Tank at about 60 seconds. Flame is highlighted in the computer drawing between the right booster and the tank, as in the case of earlier smoke puffs. At far right (arrow), vapor is seen escaping from the apparently breached External Tank.

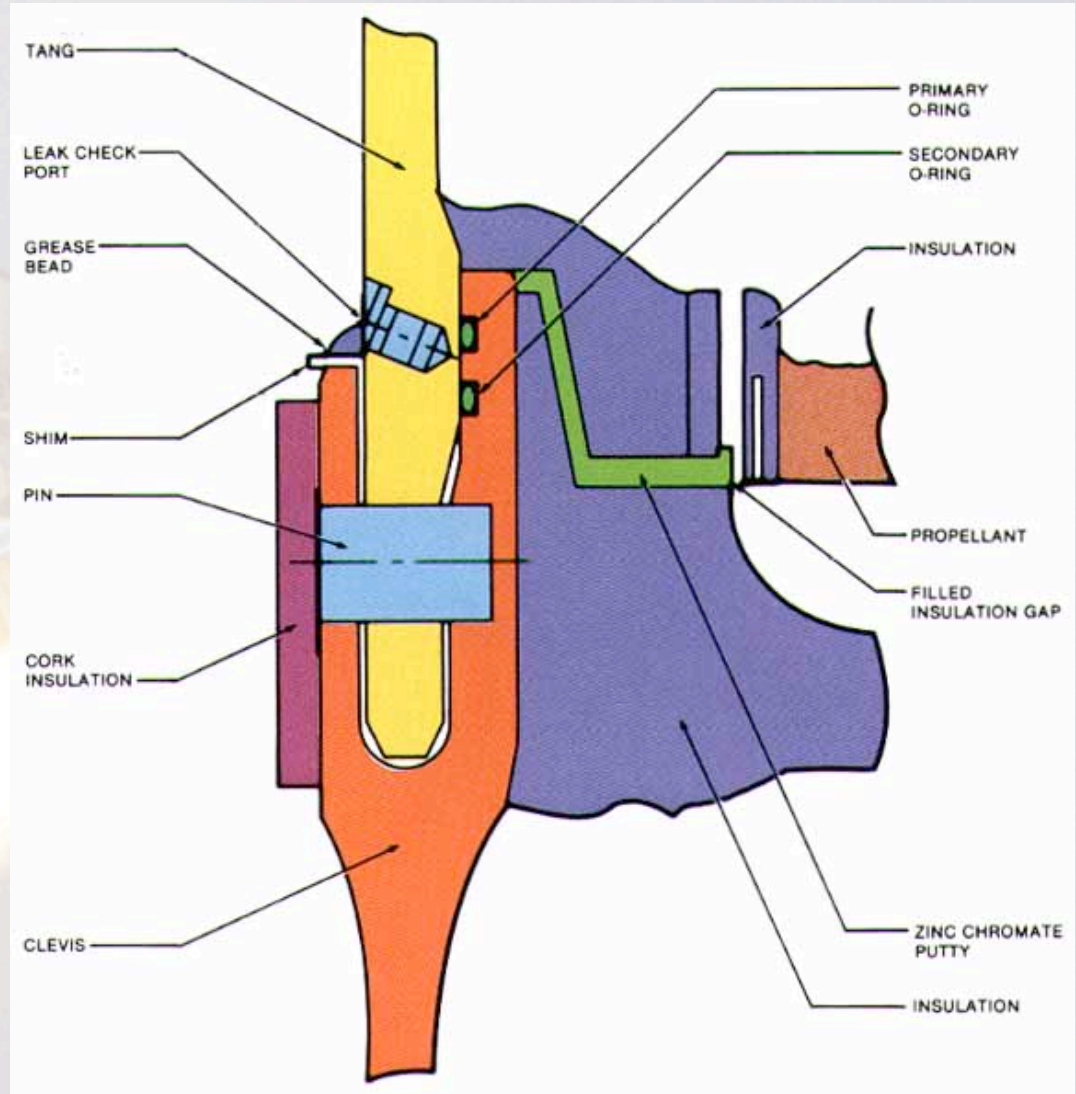
Figure 14
Solid Rocket Motor cross section shows positions of tang, clevis and O-rings. Putty lines the joint on the side toward the propellant.

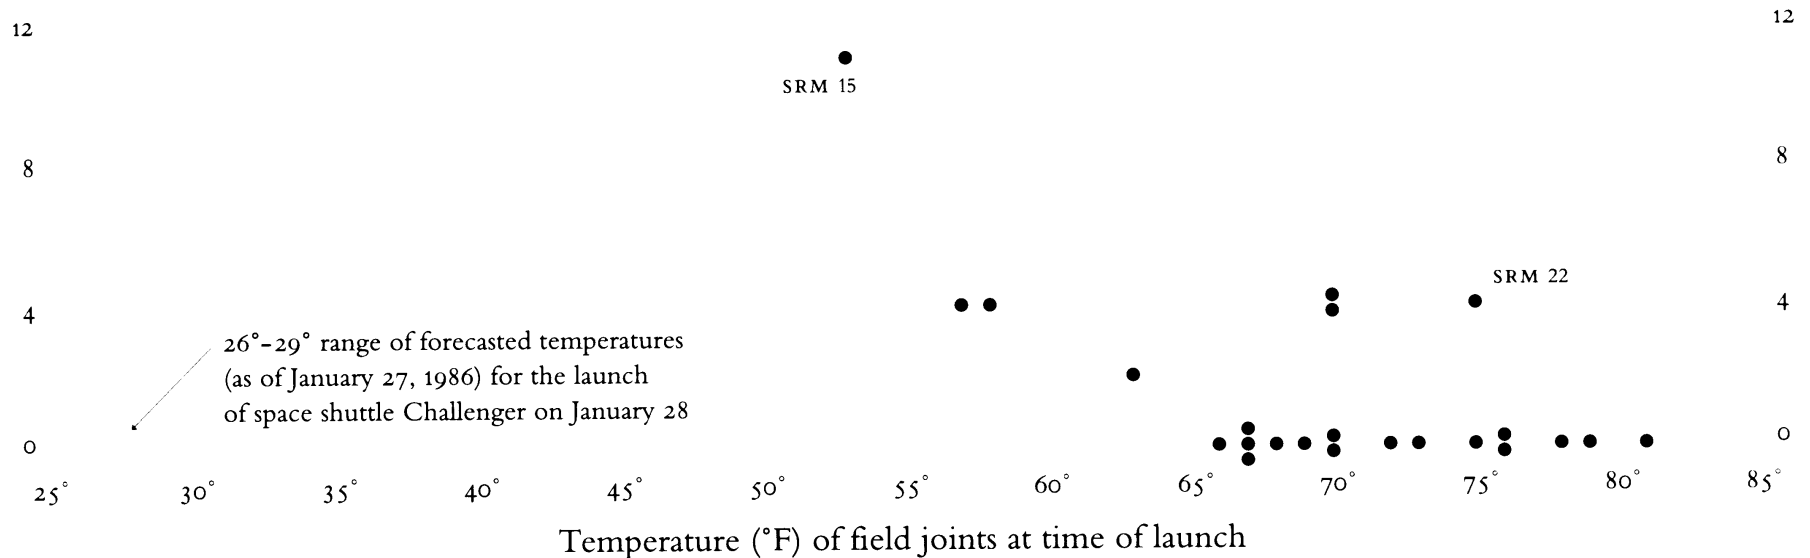
O-ring damage index, each launch

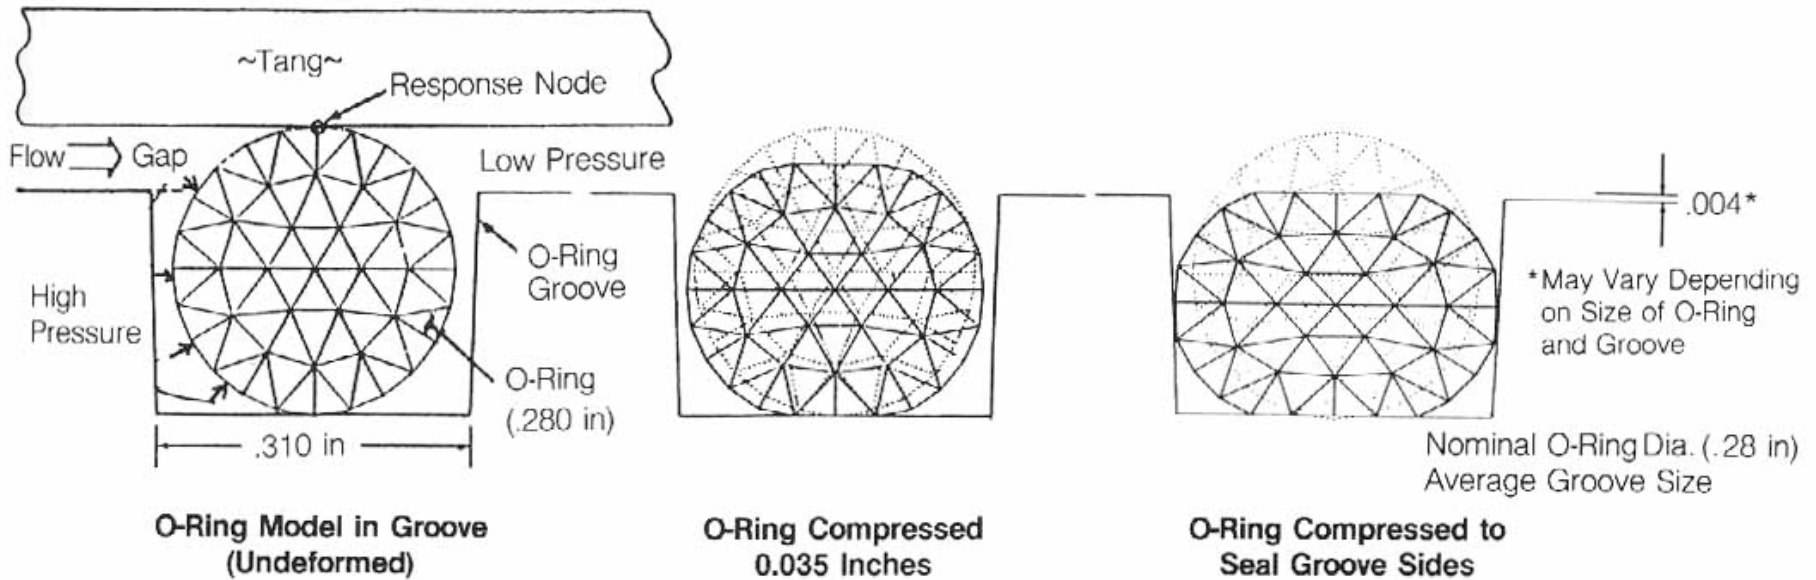
Figure 18
Drawings show how progressive reduction of gap between tang and clevis can inhibit and eventually block motor cavity's high-pressure flow from getting behind O-ring.

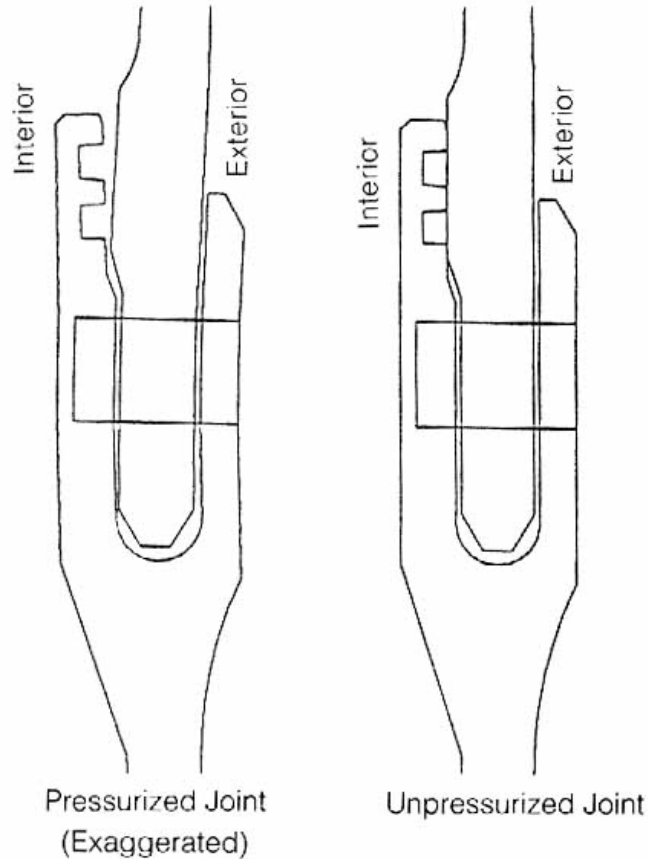
Figure 16
Drawings show how tang/clevis joint deflects during pressurization to open gap at location of O-ring slots. Inside of motor case and propellant are to left in sketches.

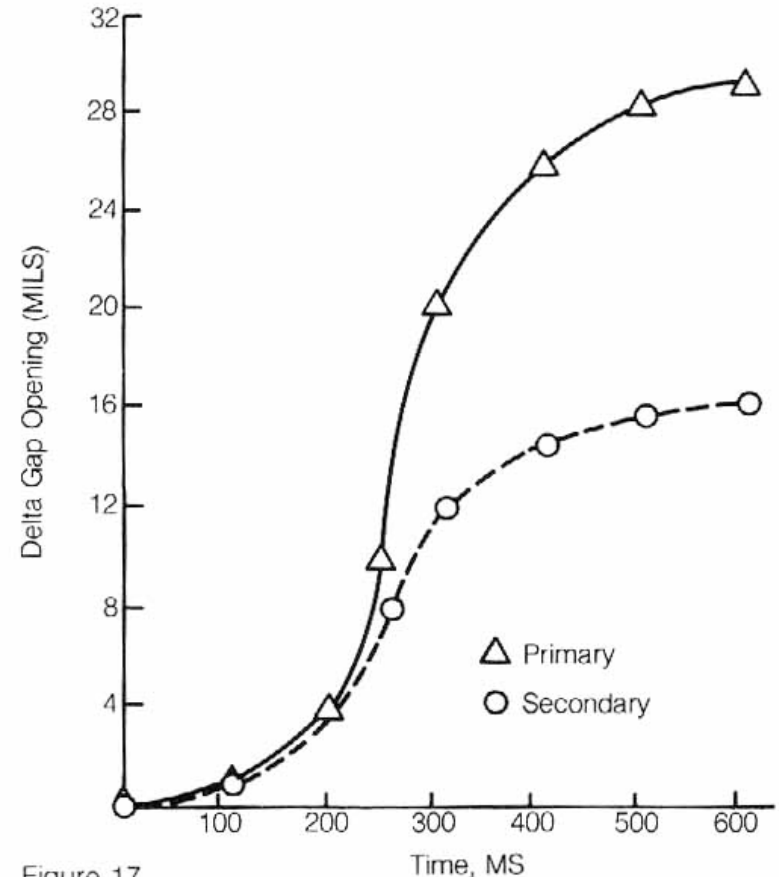
Figure 17
Graph plots changes in right booster's aft field joint primary and secondary gap openings. Horizontal scale is time in milliseconds from ignition.

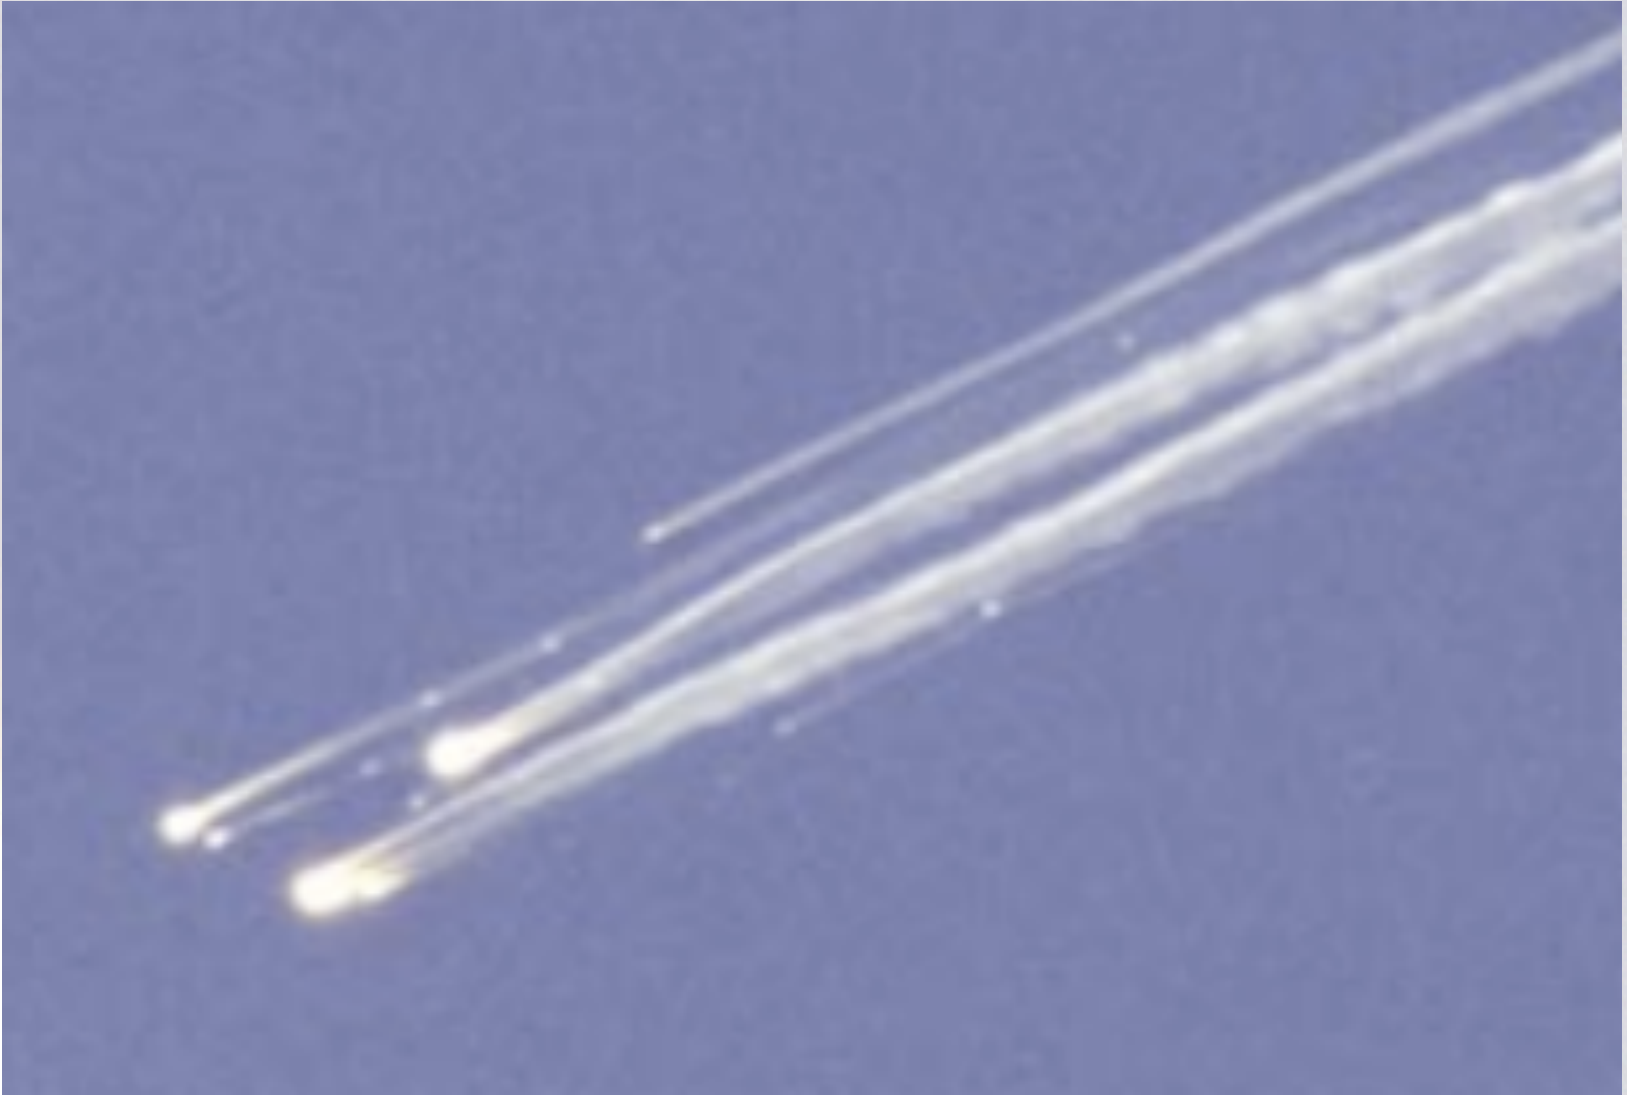
In-Flight Breakup

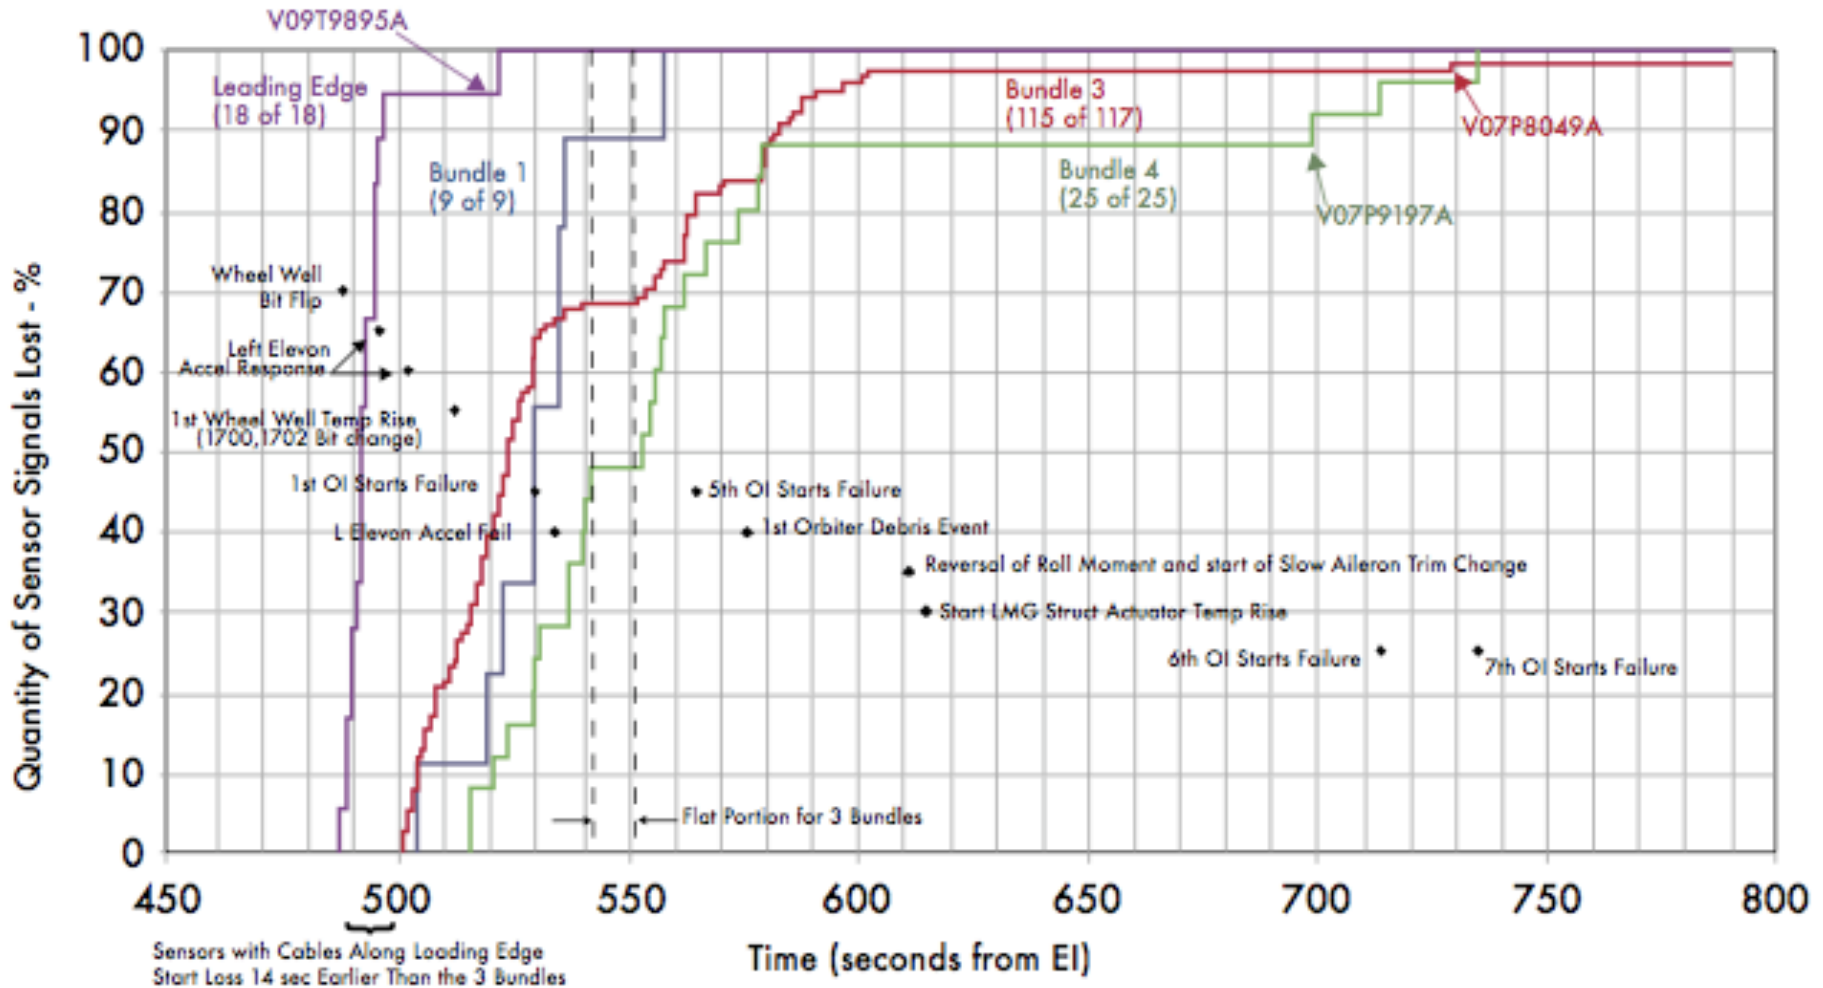
Percent Loss of Sensor Signals Versus Time In Left Wing and Wing Leading Edge Wire Bundles

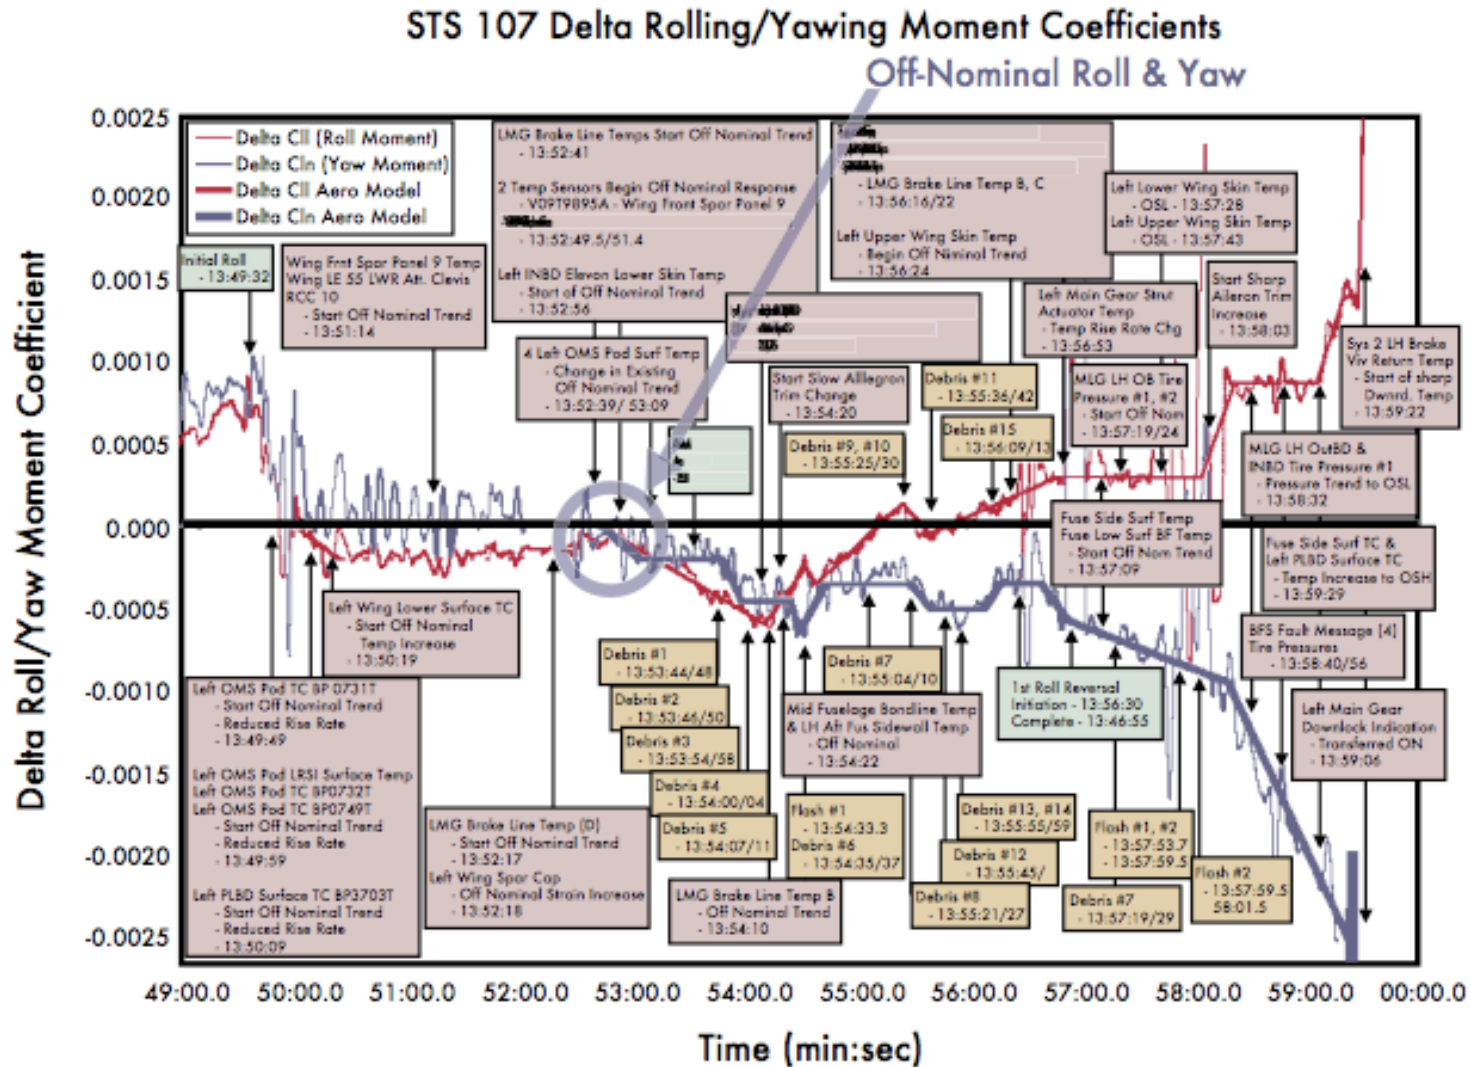
Divergence of Roll/Yaw Angles

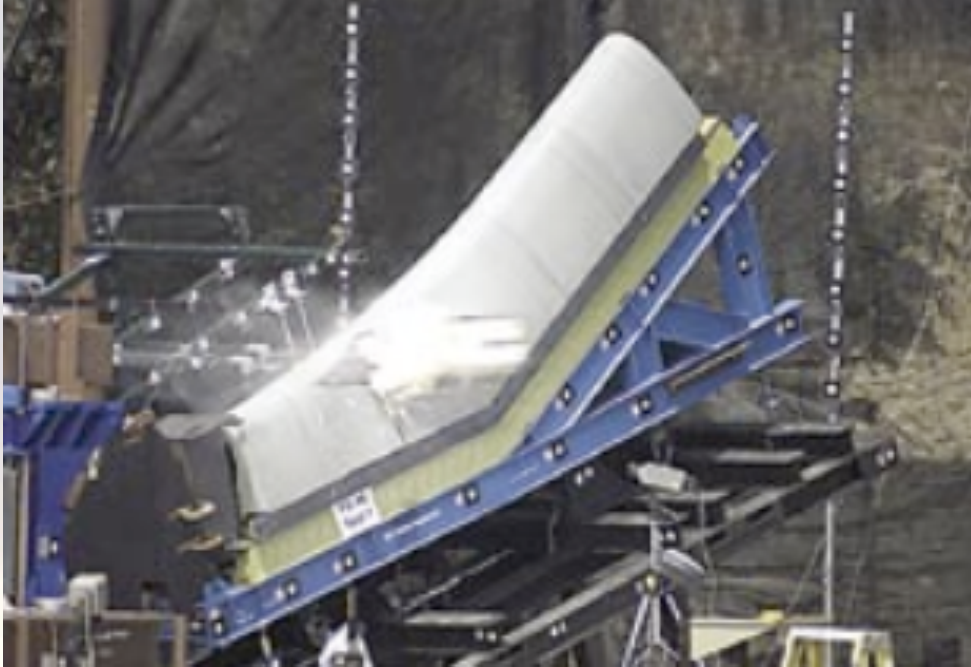
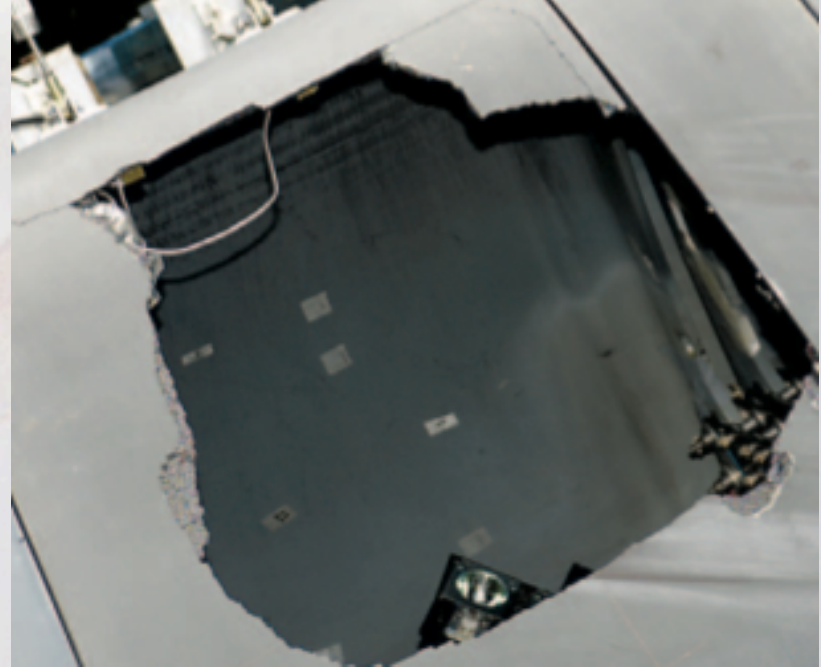
Results of Impact Tests on RCC

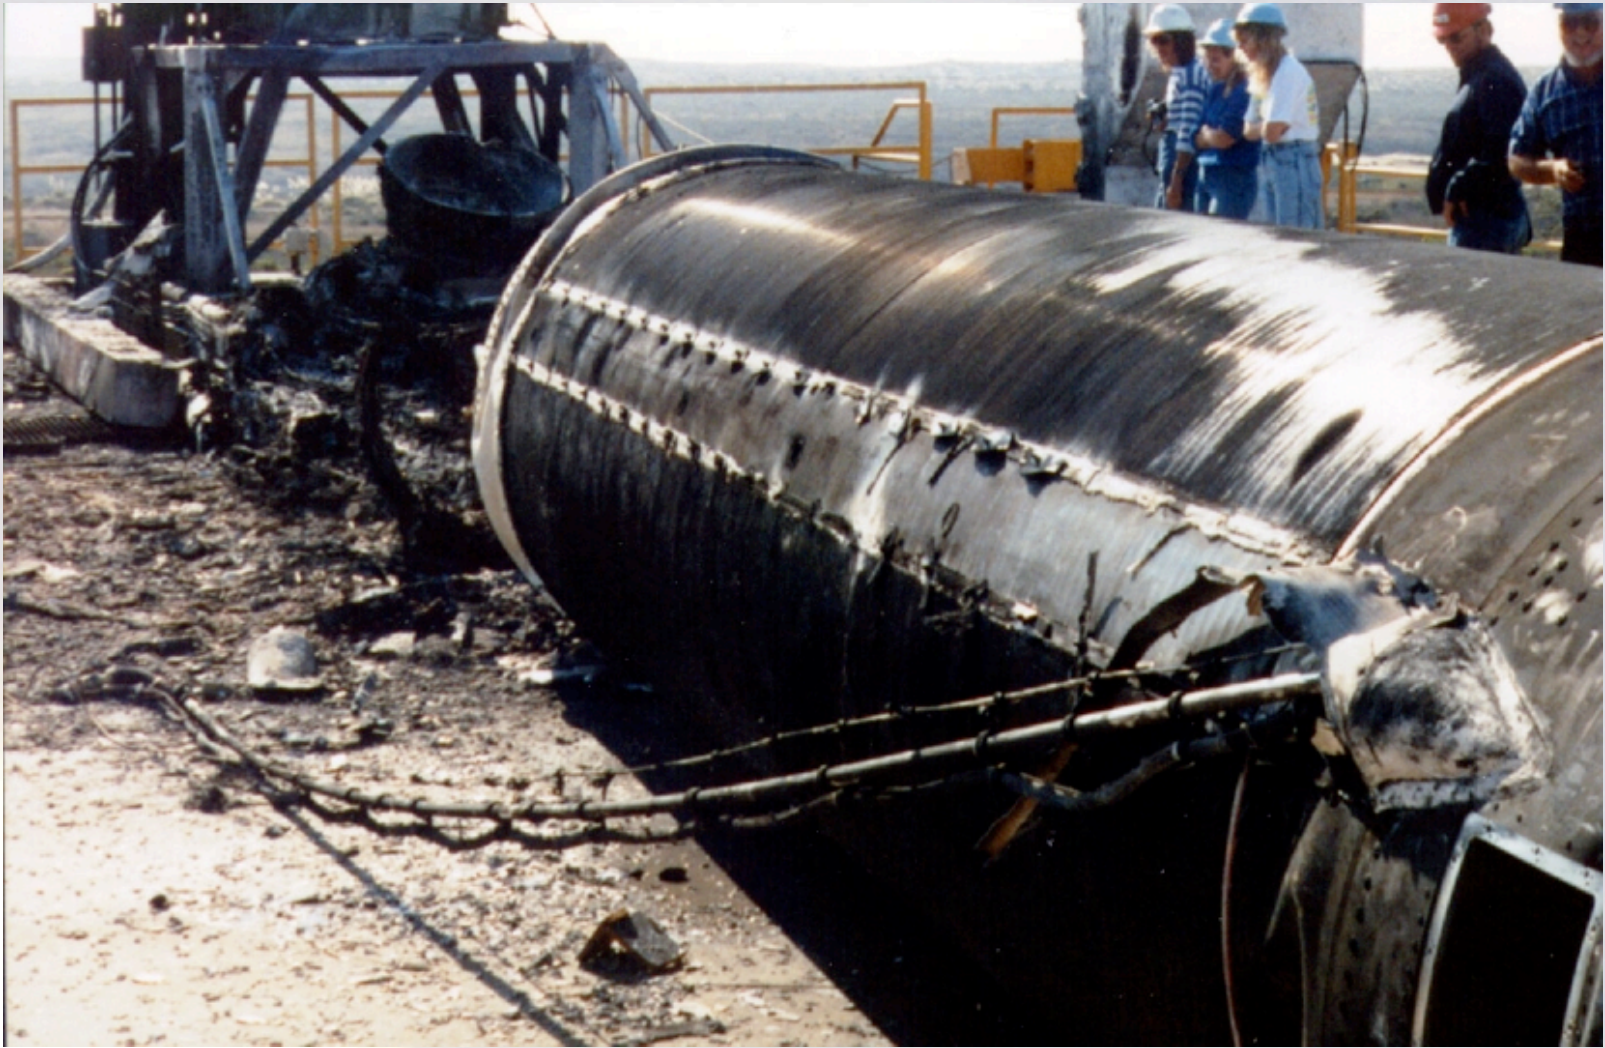
October 6, 1989 - Aftermath
