# Launch and Entry Failures

**ENAE 791 - Launch and Entry Vehicle Design**

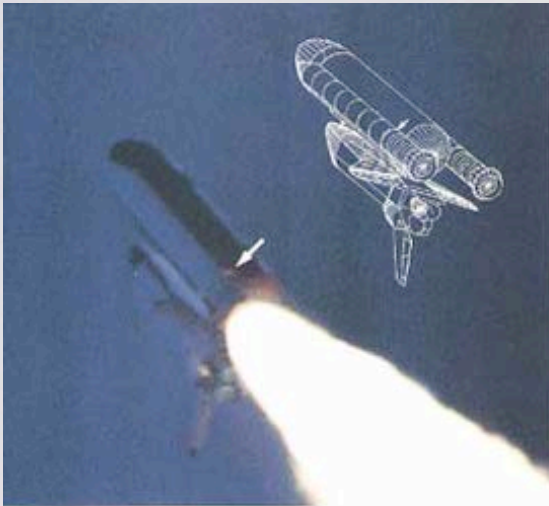
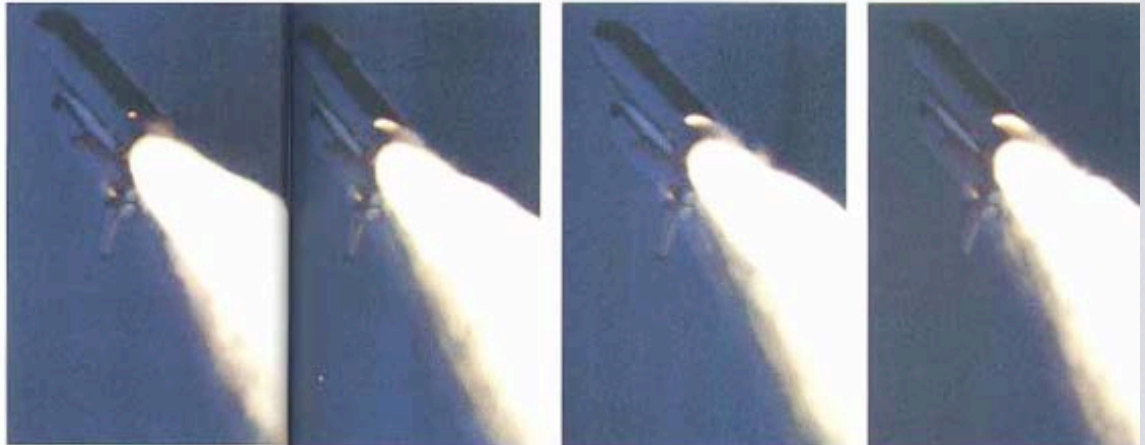
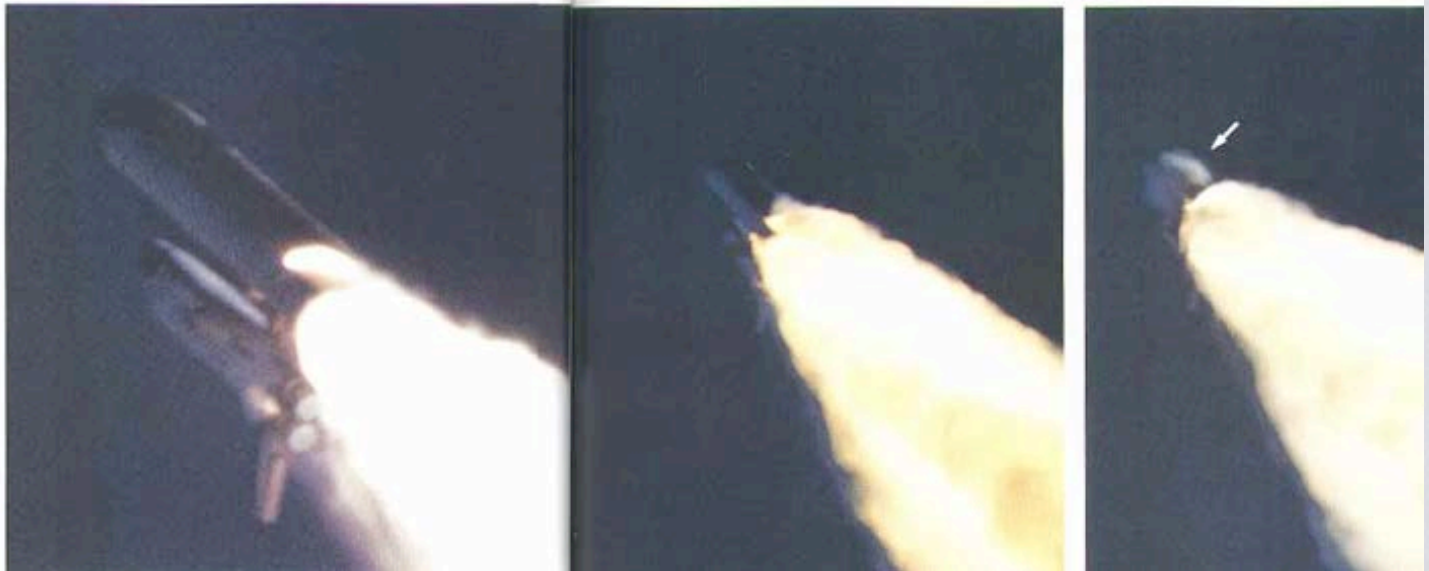
# Progression of SRB Burn-through

At 58.796 seconds, the first flicker of flame appeared. Shortly visible above, it grew into a large plume and began to impinge on the External Tank at about 60 seconds. Flame is shown in the computer drawing between the right booster and the tank, as in the case of earlier smoke puffs. At far right (arrow), vapor is seen escaping from the severely breached Lateral Tank.

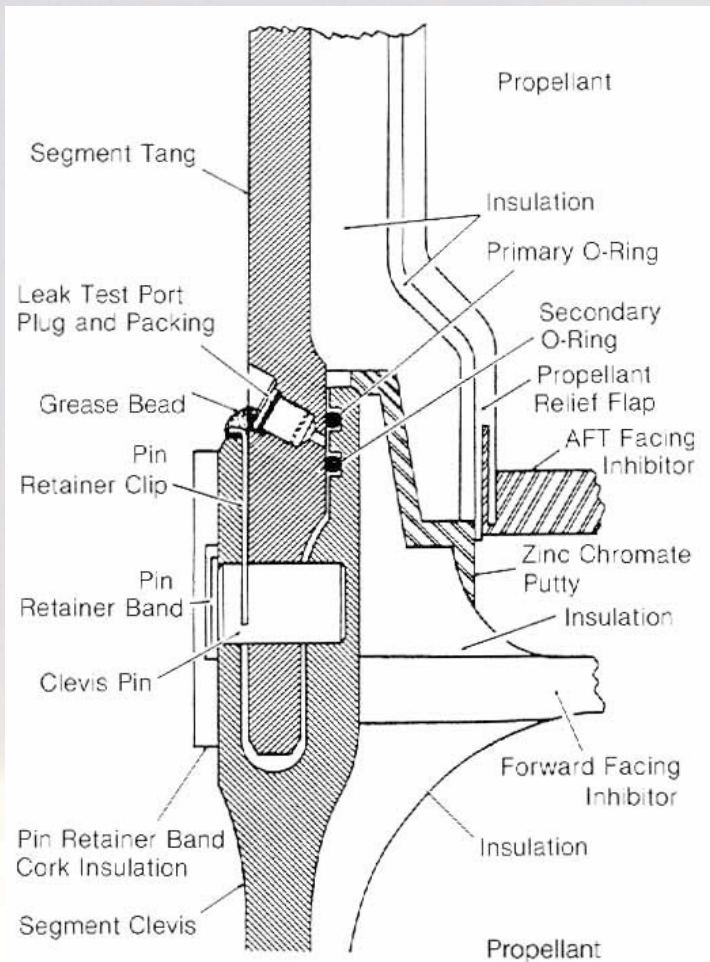
# Original SRB Field Joint Design

Figure 14  
Solid Rocket Motor cross section shows positions of tang, clevis and O-rings. Putty lines the joint on the side toward the propellant.

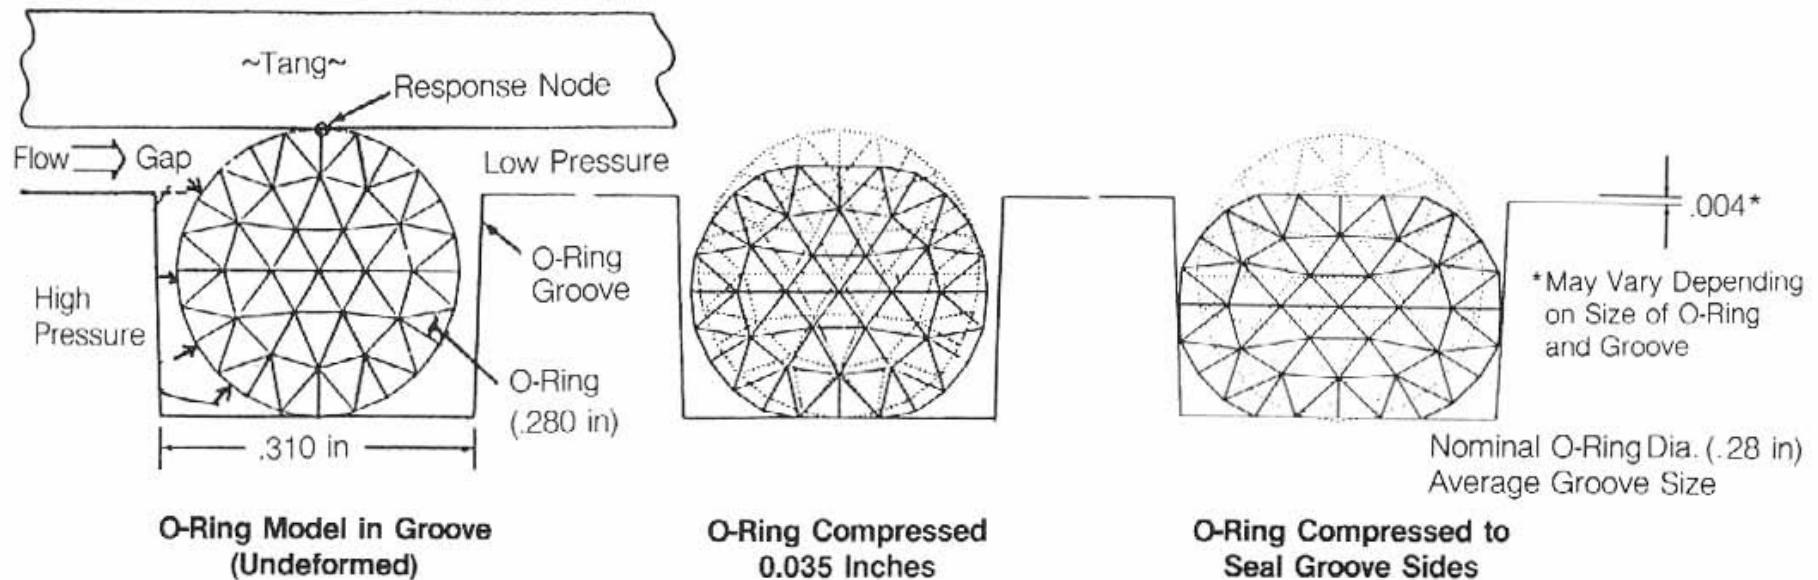
# Clearance Effects on O-Ring Seating

Figure 18  
Drawings show how progressive reduction of gap between tang and clevis can inhibit and eventually block motor cavity's high-pressure flow from getting behind O-ring.

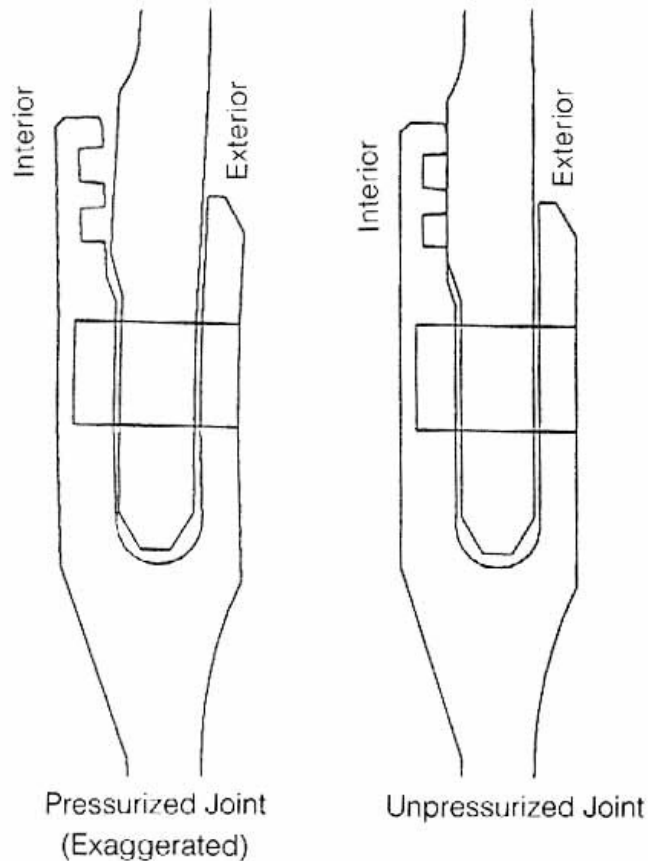
Figure 16

Drawings show how tang/clevis joint deflects during pressurization to open gap at location of O-ring slots. Inside of motor case and propellant are to left in sketches.

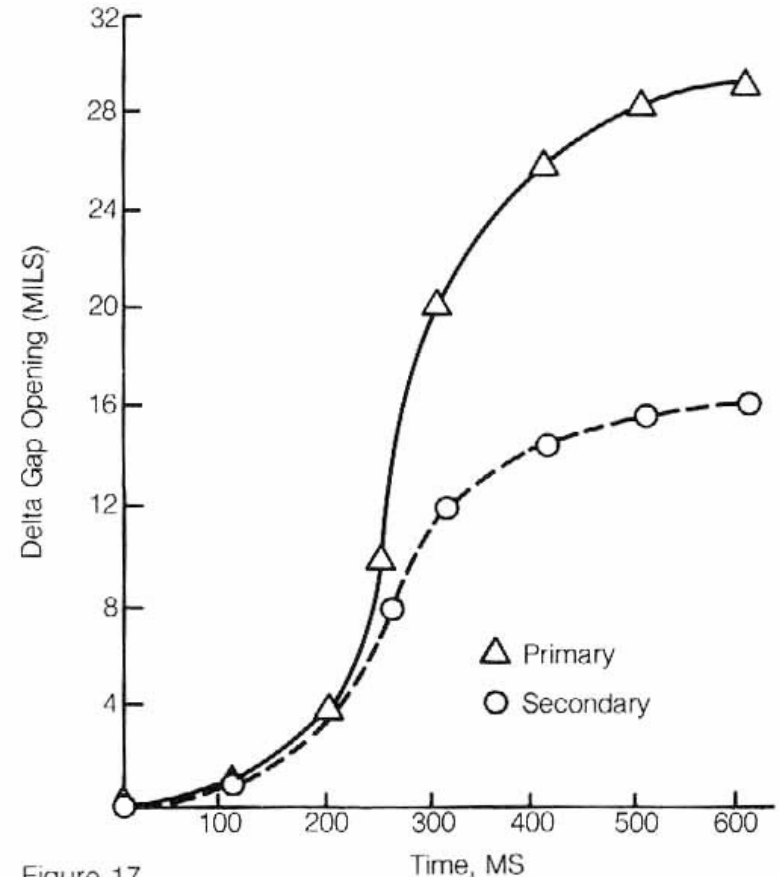
Figure 17

Graph plots changes in right booster's aft field joint primary and secondary gap openings. Horizontal scale is time in milliseconds from ignition.
