Launch and Entry Failures

- Atlas ICBM
- STS 51-L - Challenger
- STS 107 - Columbia
- AMROC SET-1

Launch and Entry Failures
ENAE 791 - Launch and Entry Vehicle Design

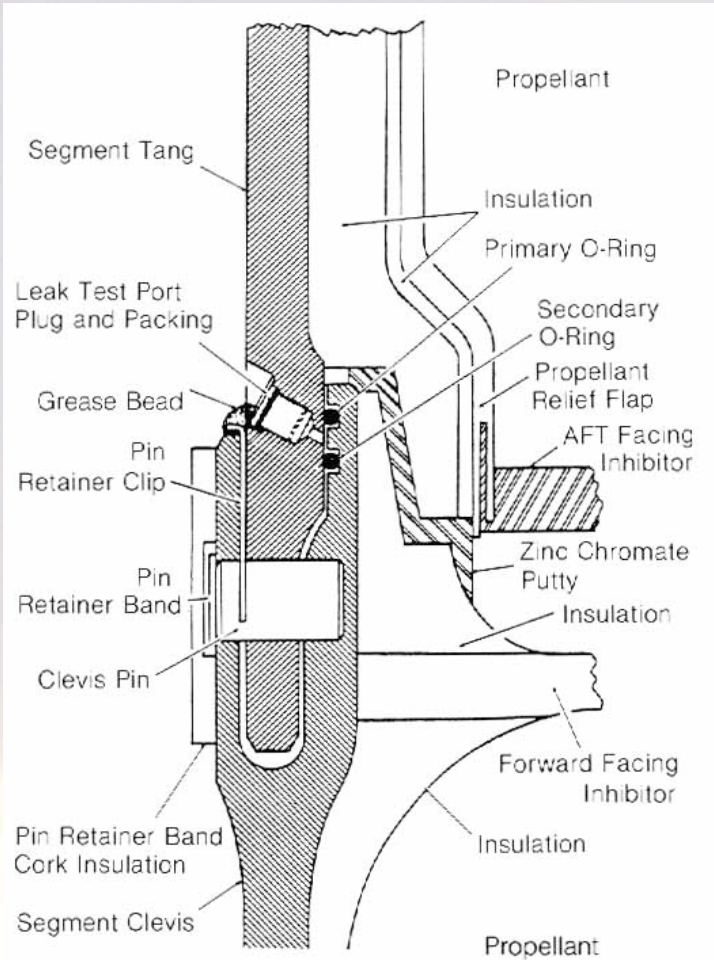
Original SRB Field Joint Design

Figure 14
Solid Rocket Motor cross section shows positions of tang, clevis and O-rings. Putty lines the joint on the side toward the propellant.
